# Seismic Hazard Evaluation of RC Buildings in İzmir after The Aegean Sea Earthquake on October 30, 2020

**Halit Cenan Mertol<sup>1</sup>, Gokhan Tunc<sup>1</sup> & Tolga Akis<sup>1</sup>**

*<sup>1</sup>Civil Engineering Department, Atilim University, Ankara, Turkey*

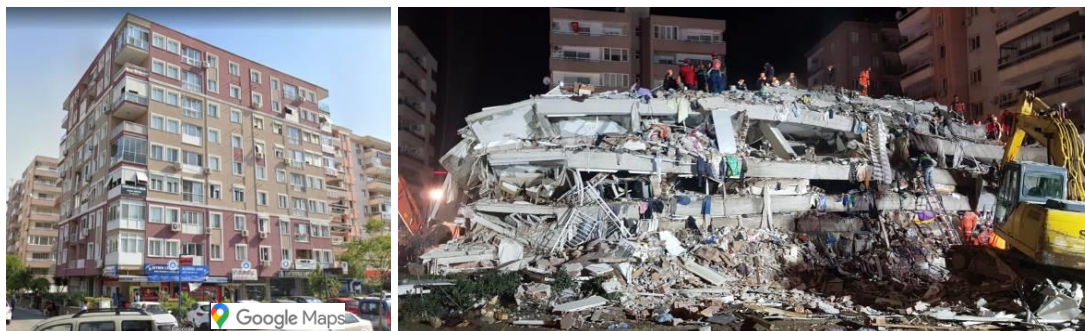
8  
9 A nine-story building, the Rıza Bey Apartment, collapsed fully during the earthquake. The construction  
10 of the building was completed in 1994. The building consisted of 32 separate apartments and 5 shops  
11 at the ground-story level. The collapse of this building started with the failure of ground story columns  
12 based on the videos shot during the collapse. After the rest of the building shifted one story down, all  
13 the other stories started to collapse progressively one by one, one on top of each other, without any  
14 translation in the horizontal direction. Photographs of the building before and after the earthquake are  
15 shown in Figure 21.

**Figure 21.** Photographs of the Rıza Bey Apartment Building before and after the earthquake

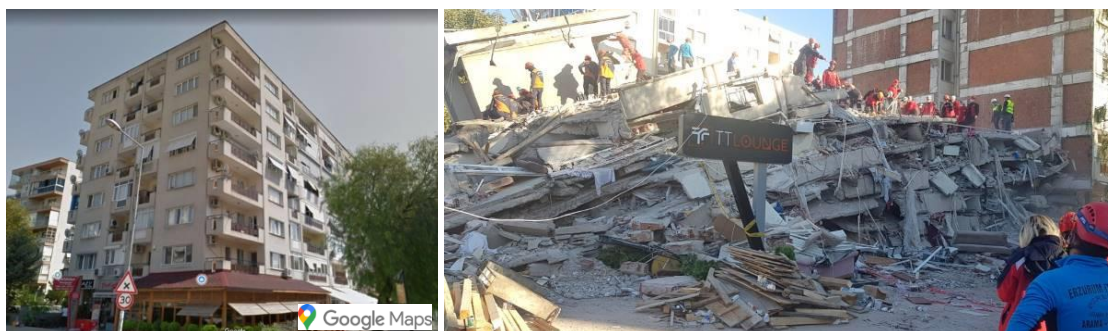
The Doğanlar Apartment Building, with its 21 apartments and 4 shops at the entrance level, collapsed approximately 1 minute after the earthquake. The construction of this 8-story building was finished in 1992. One side of this building was adjacent to another building, with a small gap in between. During its collapse, the Doğanlar Apartment Building shifted away from the adjacent building. Photographs of the building before and after the earthquake are shown in Figure 22.

**Figure 22.** Photographs of the Doğanlar Apartment Building before and after the earthquake

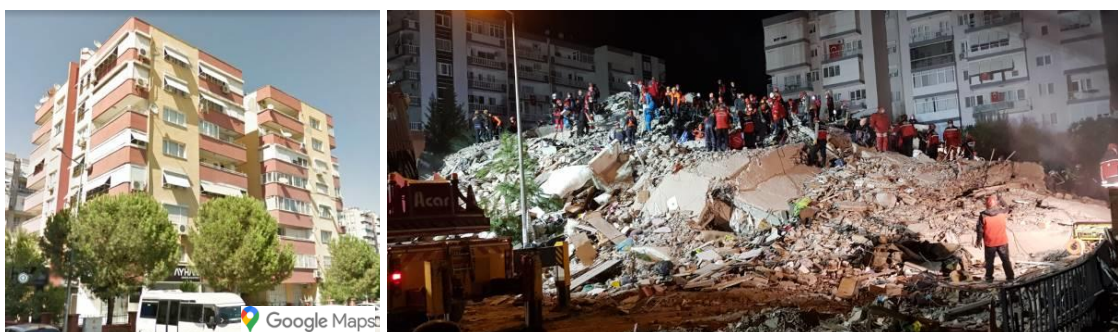
Another collapsed building was the 8-story Emrah Apartment Building, completed in 1993. The apartment housed 6 shops on its ground floor and 28 separate apartments above it. Photographs of the building before and after the earthquake are shown in Figure 23.

**Figure 23.** Photographs of the Emrah Apartment Building before and after the earthquake

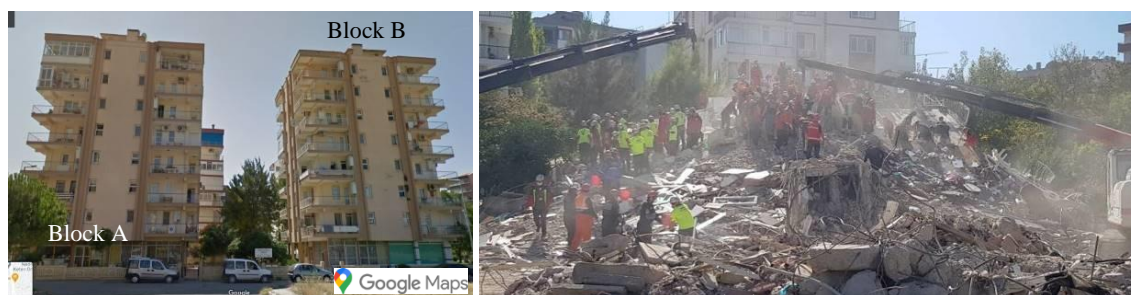
Block B of the Yağcıoğlu Apartment Complex collapsed fully after the earthquake, whereas Block A survived the earthquake with heavy damage. Each block of this apartment complex consisted of an 8 story building with 14 separate apartments and 4 shops, located at the ground level. Both buildings

3  
4  
5 **Figure 24.** Photographs of Block B of the Yağcıoğlu Apartment Complex before and after the  
6 earthquake

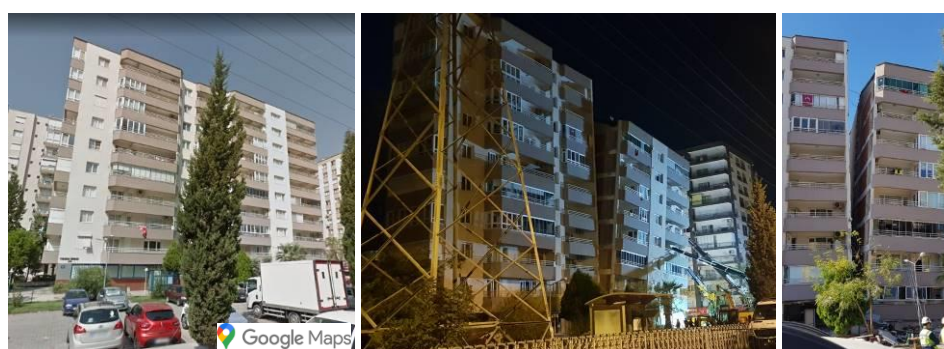
7  
8 The Yılmaz Erbek Apartment Complex consisted of two adjacent 10-story blocks. This building was  
9 constructed in the late 1990s. The ground story level consisted of shops, and the rest of the stories  
10 were comprised of separate apartments. The first two stories of one of the blocks collapsed during the  
11 earthquake. The partially-collapsed building separated from the other building and the total height was  
12 reduced. Photographs of the building before and after the earthquake are shown in Figure 25.

13  
14  
15 **Figure 25.** Photographs of the Yılmaz Erbek Apartment Complex before and after the earthquake

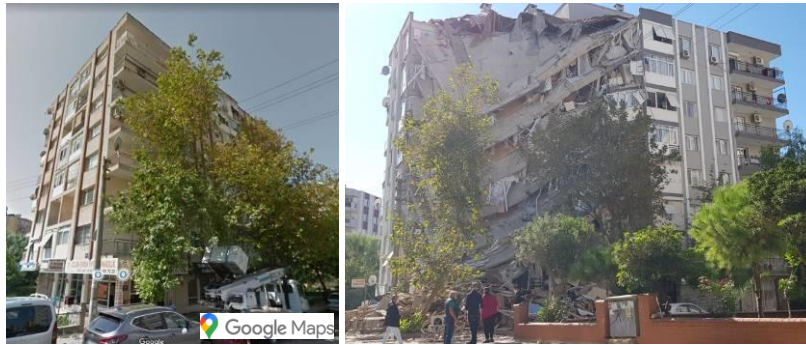
16  
17 The 8-story Karagül Apartment Building, with 28 separate apartments and shops at the ground level,  
18 was heavily damaged during the earthquake. This building was constructed in the early 1990s. Each  
19 residential story consisted of four apartments and only one fourth of the building area (corresponding  
20 to one apartment) collapsed partially a few minutes after the earthquake. Photographs of the building  
21 before and after the earthquake are shown in Figure 26.

**Figure 26.** Photographs of the Karagül Apartment Building before and after the earthquake

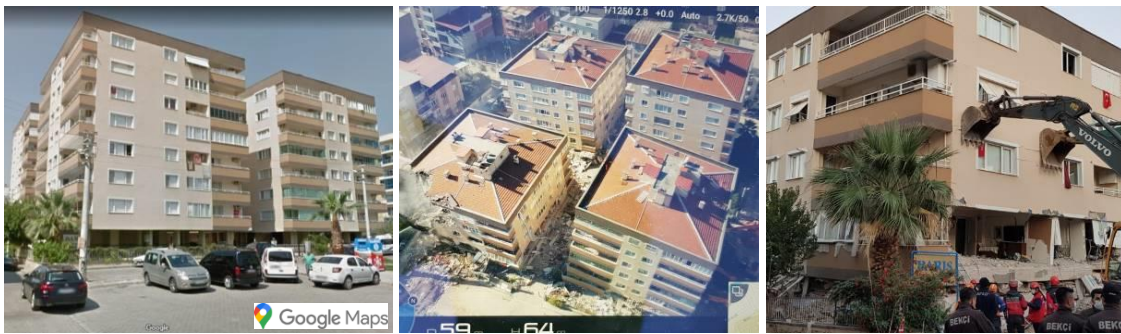
The Barış Apartment Complex, which was comprised of four blocks with 8 stories each, was constructed in 1992. Three of these buildings partially collapsed and one of them experienced extensive damage without collapse. The first four stories of the two blocks and the first three stories of the other block collapsed on top of each other. The stories over the collapsed portion of the buildings survived the earthquake by leaning towards one side of the buildings. Photographs of the Barış Apartment Complex before and after the earthquake are shown in Figure 27.

**Figure 27.** Photographs of the Barış Apartment Complex before and after the earthquake

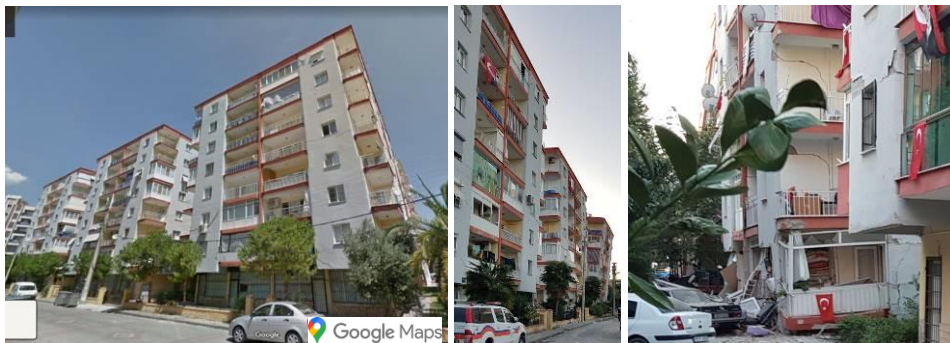
A similar failure mode was observed in the Cumhuriyet Apartment Complex constructed in the early 1990s. The complex consisted of 3 blocks with 8 stories each. One block survived the earthquake with heavy damage; however, the first story of the other two blocks collapsed, causing the uncollapsed section of the buildings to shift one story down. Photographs of the Cumhuriyet Apartment Complex before and after the earthquake are shown in Figure 28.

**Figure 28.** Photographs of the Cumhuriyet Apartment Complex before and after the earthquake

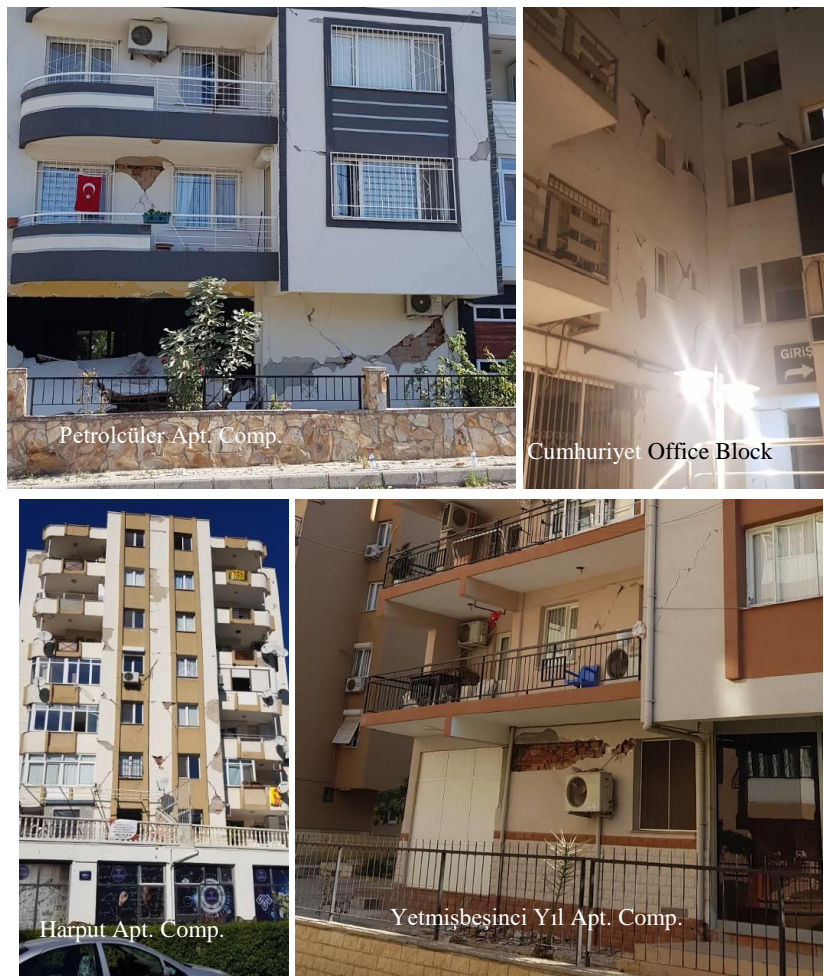
2 There were numerous severely damaged buildings in the city of İzmir during the Aegean Sea  
 3 earthquake. One of the typical damage types was diagonal cracking on structural (beams, columns,  
 4 and shear walls) and non-structural (partition walls) elements, as shown in Figure 29. The structural  
 5 damage on the columns were also very significant in some of the buildings, as shown in Figure 30. On  
 6 the other hand, some of the buildings constructed side by side were separated due to the collision  
 7 (hammering effect) of these buildings moving in opposite directions during the earthquake. This type  
 8 of motion results in the damage of the structural elements of these buildings. An example of this  
 9 behavior is shown in Figure 31.

**Figure 29.** Diagonal cracks on structural and non-structural elements

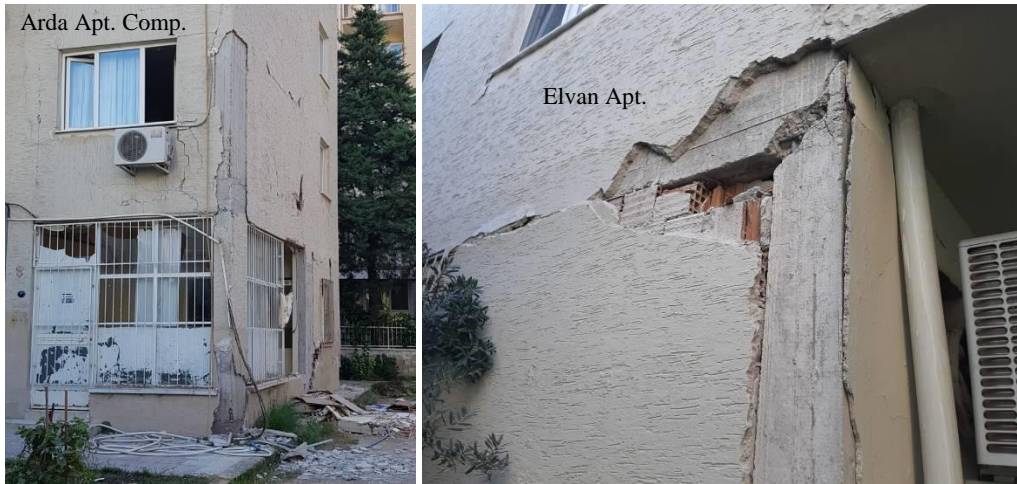
Figure 30. Severe column damage

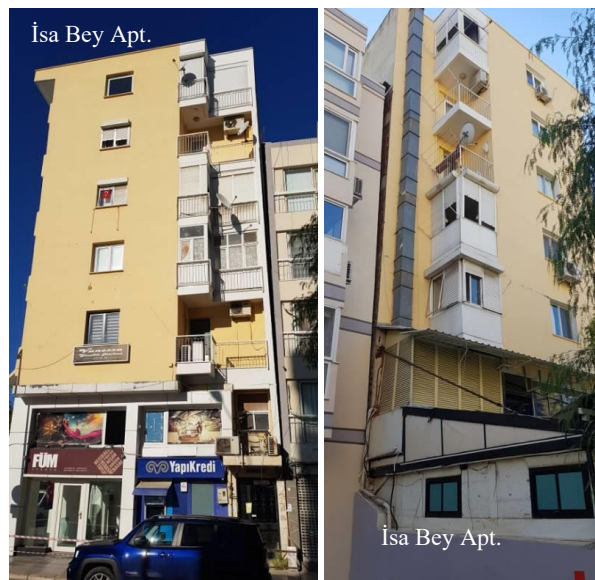
Figure 31. Separated buildings constructed side by side

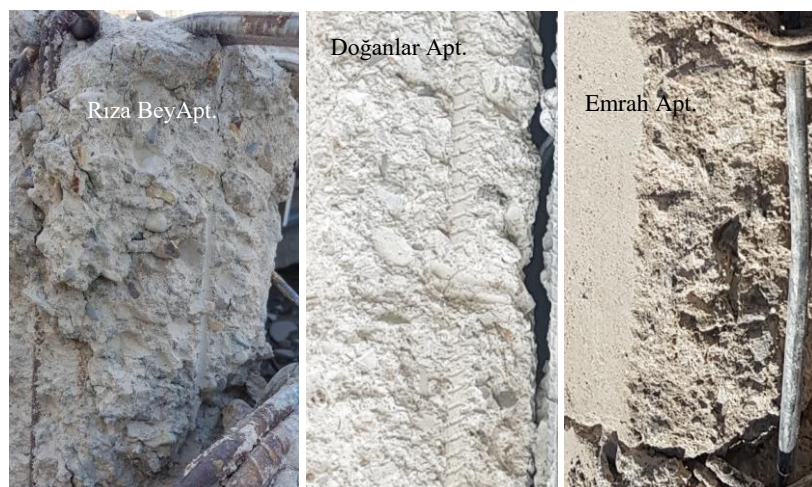
6 **Figure 33.** Concrete quality in various collapsed buildings

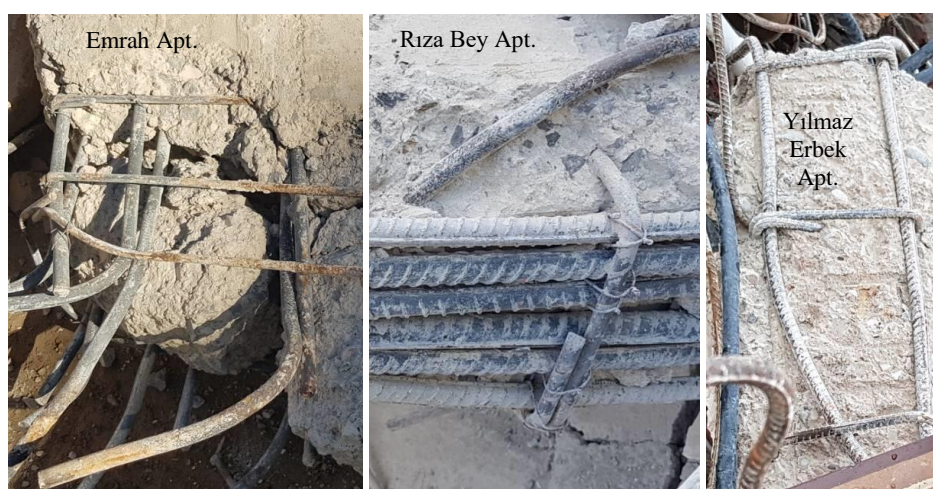
20 **Figure 34.** Reinforcement types in various collapsed buildings

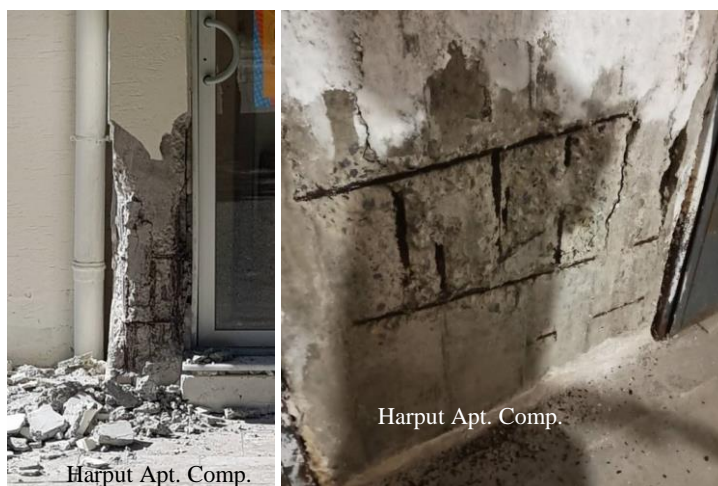
1 Most of the buildings in the area had moisture problems due to the humid climate, the high water table  
2 level, and insufficient water insulation, especially at the ground floor level. Therefore, the  
3 reinforcements of the structural members of these buildings corroded extensively, resulting in  
4 significant reduction of the cross-sectional area of the reinforcements. Examples of corroded  
5 reinforcements are shown in Figure 35. It is important to note that these mistakes are repeating  
6 themselves when building damage is investigated in most earthquakes. For instance, the field  
7 observations recorded after the Sivrice, Elazığ, Turkey earthquake on January 24, 2020, are an  
8 example of this [51].

11  
12 **Figure 35.** Corrosion of reinforcements due to moisture

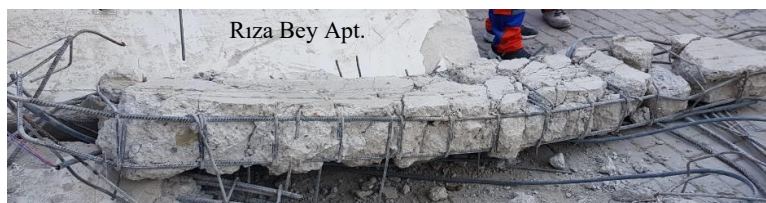
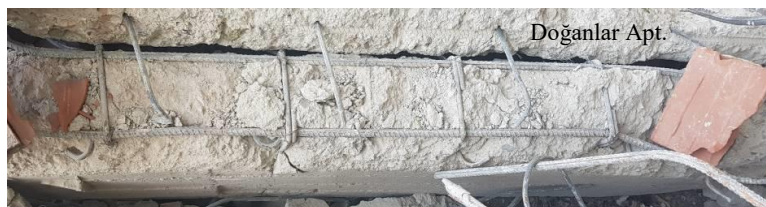
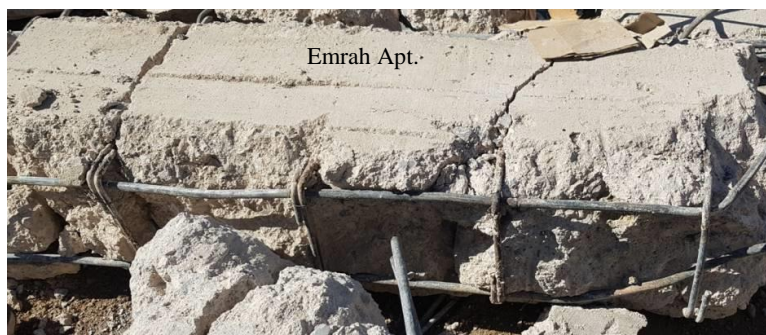
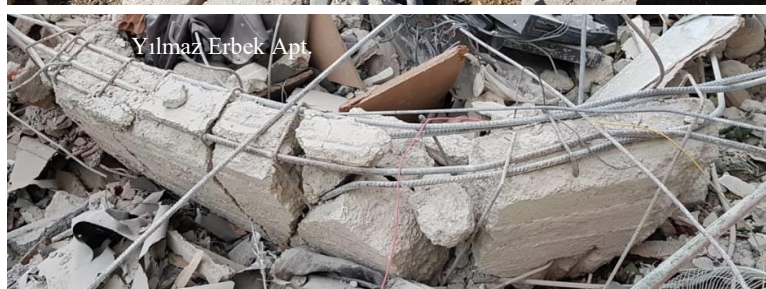
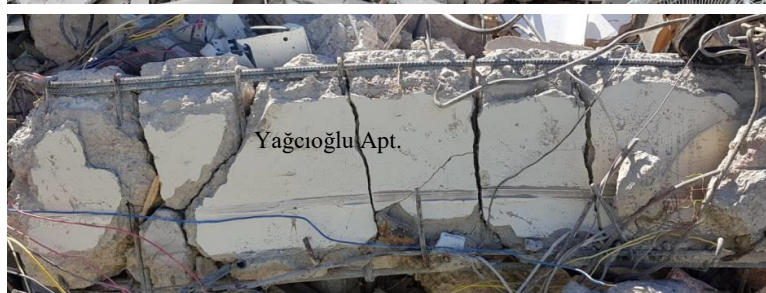
6 **Figure 36.** Reinforcement configurations of the columns and beams of the collapsed buildings

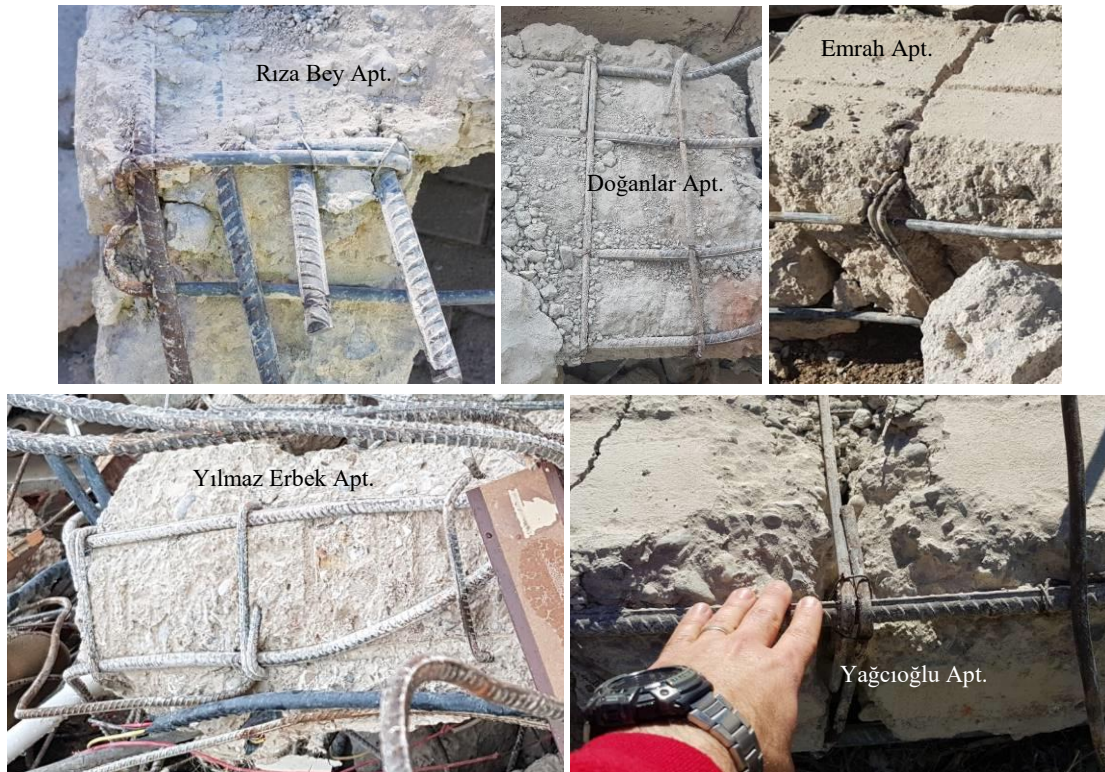
8 Although TEC (1975) [46] required bending the ends of the stirrups into the concrete core (135°  
9 hooks), the ends of the stirrups were only bent 90°, resulting in the opening of the stirrups after the  
10 spalling of the cover concrete in the beams and columns. Photographs of these stirrups in various  
11 collapsed buildings are shown in Figure 37. As with the observation made in the materials section, the  
12 issues related to reinforcement configuration are another problem that has been frequently observed  
13 in Turkey following an earthquake.

Figure 37. Ends of the stirrups (bent 90°) of the collapsed buildings

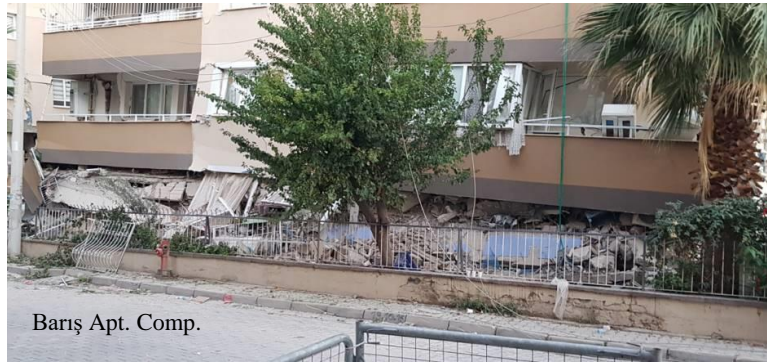
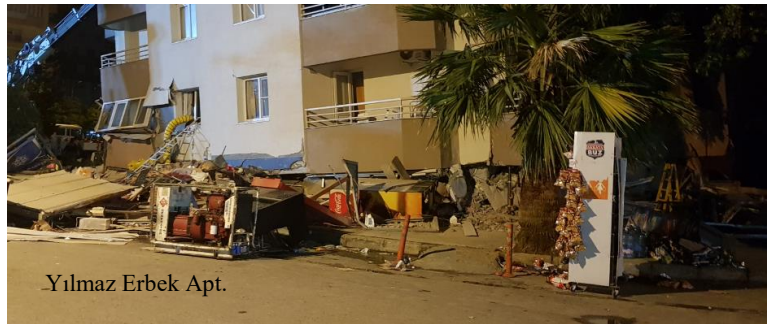
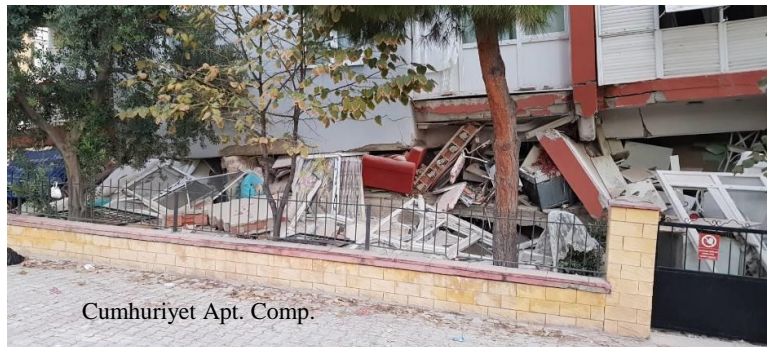
TEC (1975) [46] did not define any irregularity based on story stiffness. The effect of this type of irregularity was first introduced into the earthquake code in 1998 [47]. The strong beam-stronger column requirement also first appeared in TEC (1998) [47]. The first few stories of some of the buildings collapsed like a sandwich during the earthquake. These buildings had story stiffness irregularities at the ground story level which probably played a major role in the collapse. Photographs of these buildings are shown in Figure 38.

**Figure 38.** Collapsed buildings due to the failure of first story columns

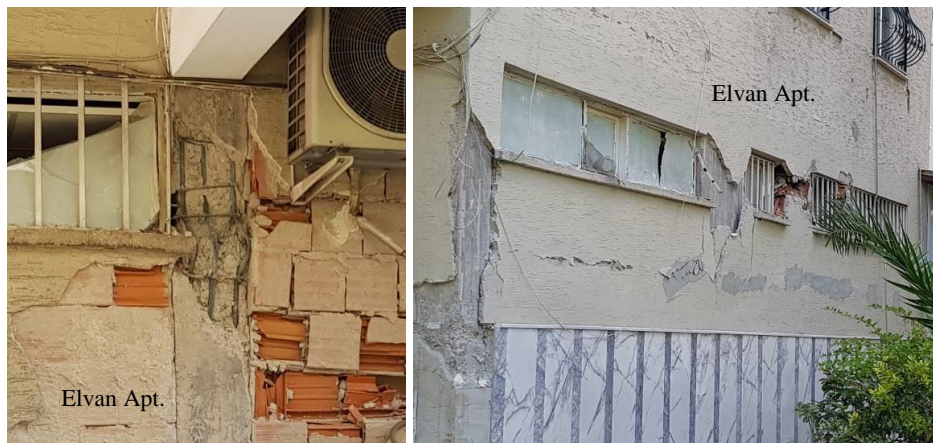
According to TEC (1975) [46], the confinement of transverse reinforcement was applied along the length of the short columns. An example of damage due to short columns after this earthquake is shown in Figure 39. No confinement of reinforcement was observed along the short columns.

**Figure 39.** Short column formation in a severely damaged building

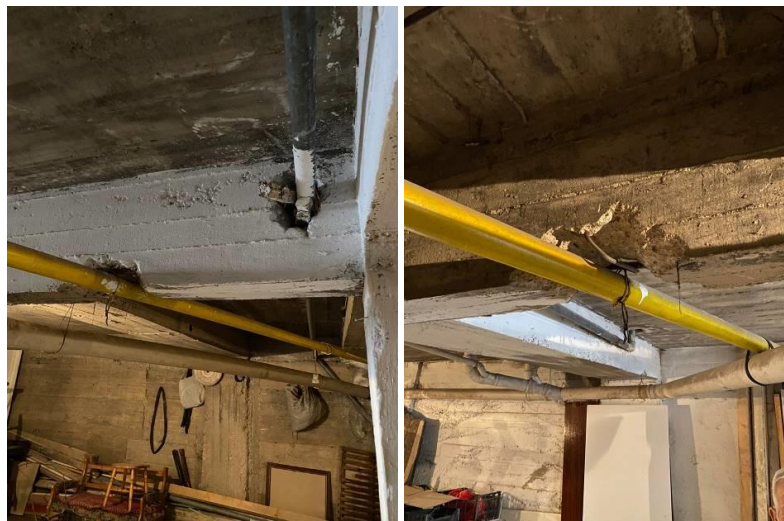
The inspection mechanism before (the design stage) and during the construction process changed significantly in the 2000s. After the earthquake, the conditions of numerous damaged buildings in İzmir were investigated by experts from the Turkish Ministry of the Environment and Urbanization. Based on their findings, some of the buildings were determined to be unsafe for occupants, and were either demolished immediately, or designated to be repaired and/or strengthened. During this post-earthquake assessment process, it was observed that the structural members of some of the buildings were damaged or destroyed for various reasons, before the earthquake. Examples of this type of damage and destruction are shown in Figure 40. The bottom longitudinal reinforcement of the basement beam shown in this figure was cut at the midspan, and the top longitudinal reinforcement was damaged at the support region in order to install utility pipes inside the building. The stirrups at the damaged sections were also cut.

**Figure 40.** Beam damaged due to plumbing (Karşıyaka, İzmir)
