**ROAD SAFETY AUDIT AND A CASE STUDY
ON AKYURT – KALECİK ROAD**

**A THESIS SUBMITTED TO
THE GRADUATE SCHOOL OF NATURAL AND APPLIED SCIENCES**

THE DEPARTMENT OF CIVIL ENGINEERING

OCTOBER 2010

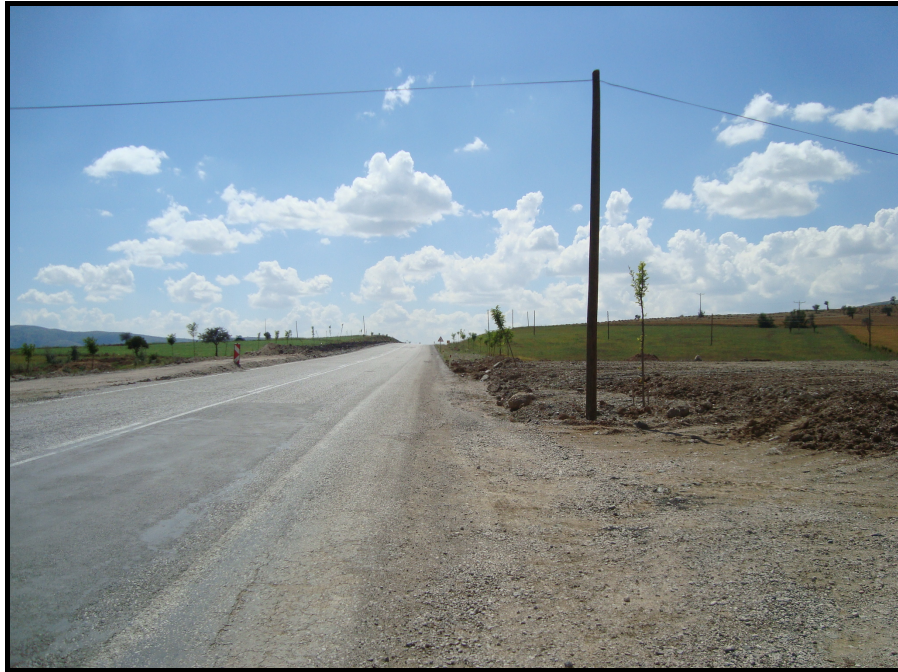
Figure 4.3 Wooden pole inside the safety zone

Along the audit route the most noticeable pole type is the telephone poles which are made of wood. The telephone poles are located inside the safety zone at most places. They are located both sides of the route. These locations are found to be associated with frequent utility pole crashes due to run off the roadway accidents. (figure 4.3)

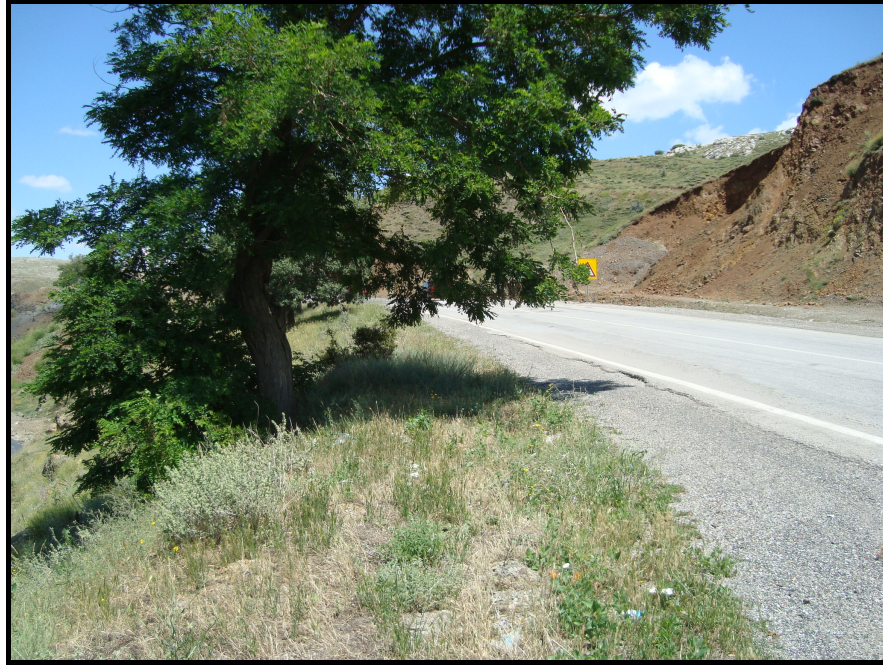
Figure 4.4 Tree is in the roadside safety zone

Some of the trees are lined at the beginning section of the route and all of the trees are in the safety zone area. Between km 28+500 and km 28+800 trees so close to the road. Between km 41+300 and 41+500 the sight distance is prevented by trees. At station km 34+900 the tree is also in the safety zone area (figure 4.4). Some sections of the route the shoulders are covered by small bushes which are located at station km 50+200.

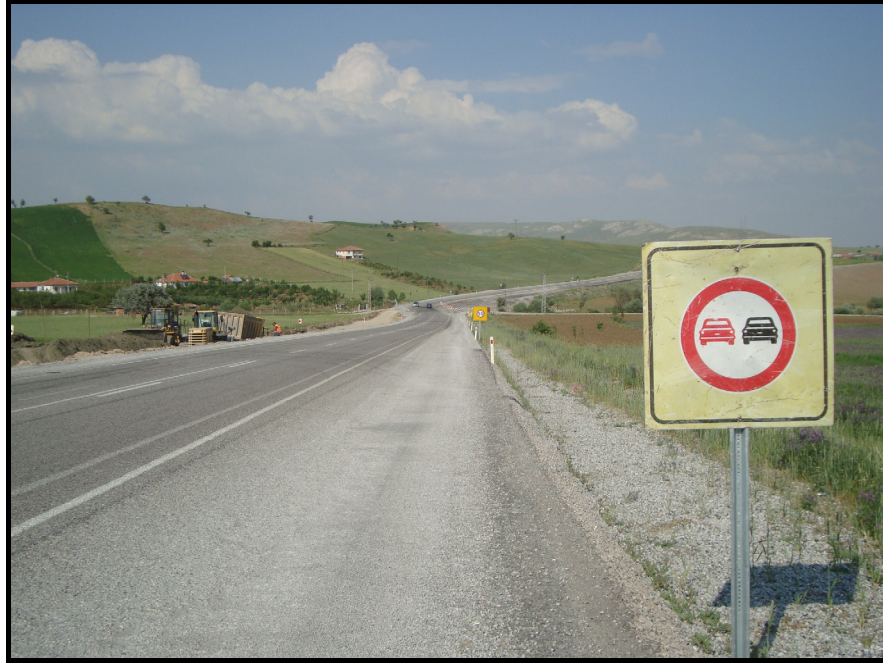
Figure 4.6 Improper sign usage

Some of the information signs are located at inappropriate locations. Nevertheless the passing sight distance is appropriate for the section of the route, which is station km 42+300, there is a overtaking prohibited sign (figure 4.6). Beside this the sign is also worn out. This section's old and new markings are mixed into each other. At station km 55+000 vertical sign is inside the shoulder area. Moreover there are missing markings sections on the audit route.

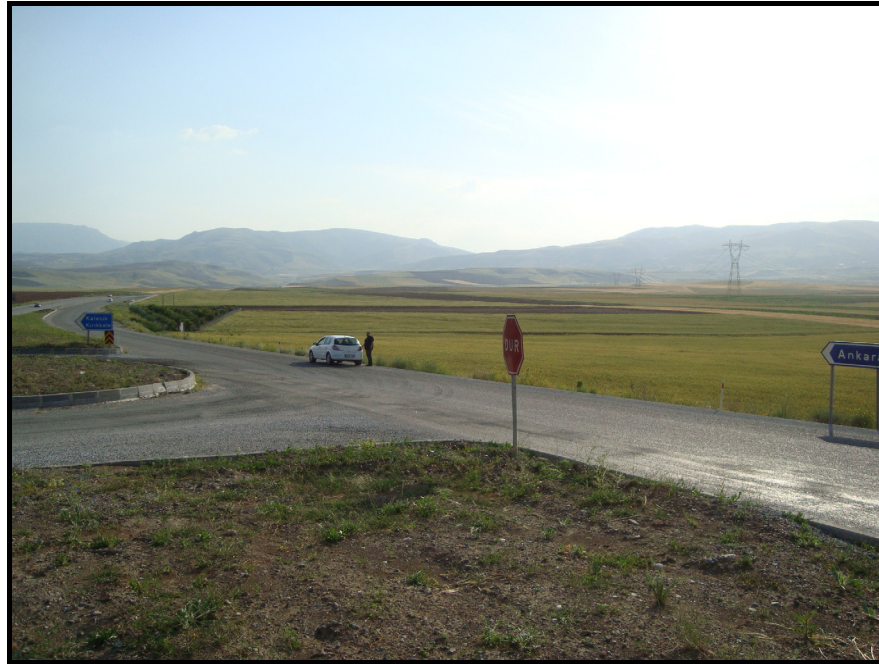
Figure 4.7 Improper junction design

There is a potentially hazardous situation, particularly for traffic traveling in Çankırı direction, at the intersection with sideway at station km 38+200. Because the sideway intersects the audit route at the apex of one of its horizontal curves, it results

in optical confusion for drivers. It appears as if the audit route continues straight ahead (with no curve) but in fact, it is sideways which intersects the highway at this location. This would confuse drivers, especially at night, if there is a vehicle traveling towards the intersection on sideway.

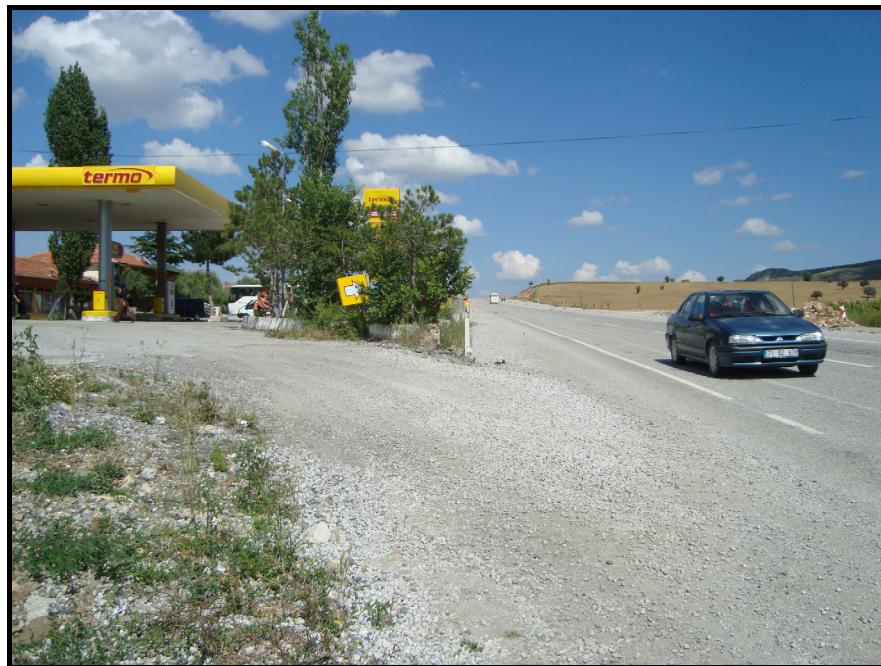
Figure 4.8 Dangerous exit section of gas station

At station km 54+500; there is another gasoline station, which is on the left way and the divided section of the route. Also a big information board is located within the safety zone. This information board can increase the severity of accidents.

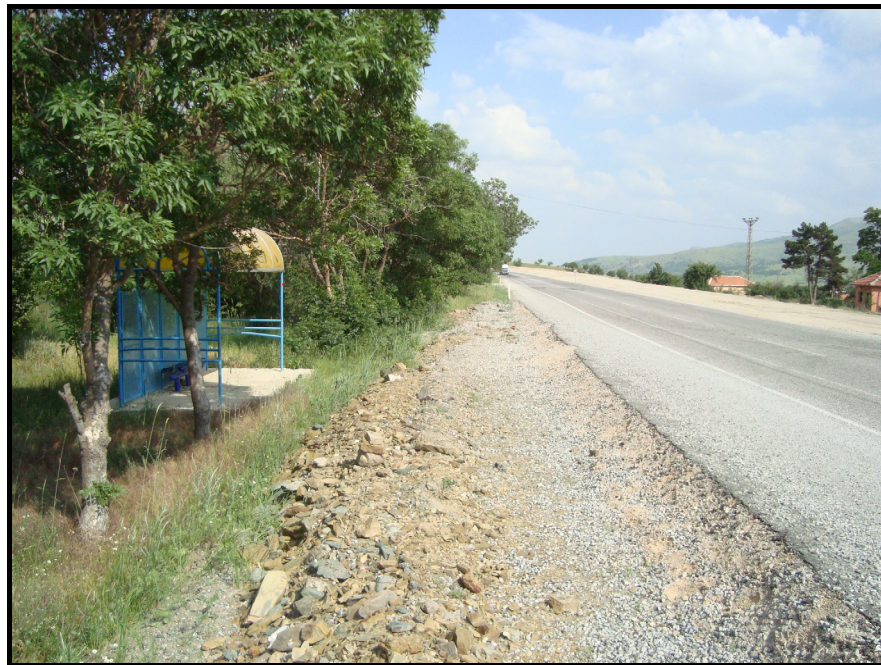
Figure 4.9 Invisible bus stop is in the roadside safety zone

Improper bus stops can be accepted as dangerous fixed objects which are located in the safety zone of the roadway. These bus stops can increase the risk of serious injury and damage accidents.

One of the bus stops is just located on the tangent section of the horizontal curve. This area also creates risk for vehicles. Because of the bus stop's high construction material might increase the severity of collisions. Another bus stop is almost out of the bus driver's sight area. The sight distance is obstructed by trees (figure 4.9). In addition to this, at station km 44+800 one of the bus stop sign is on the electricity pole. It is not visible for bus driver because of its improper design.

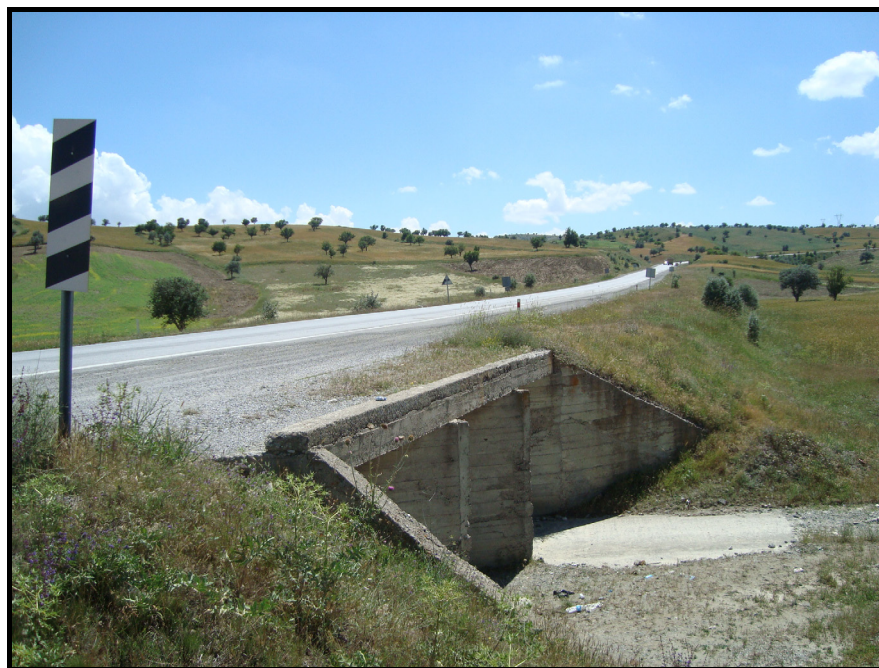
Figure 4.10 Dangerous transition zone of culvert without guardrail

might increase the severity of accidents (figure 4.10). At km station 55+800 there is another culvert without guardrail protection.

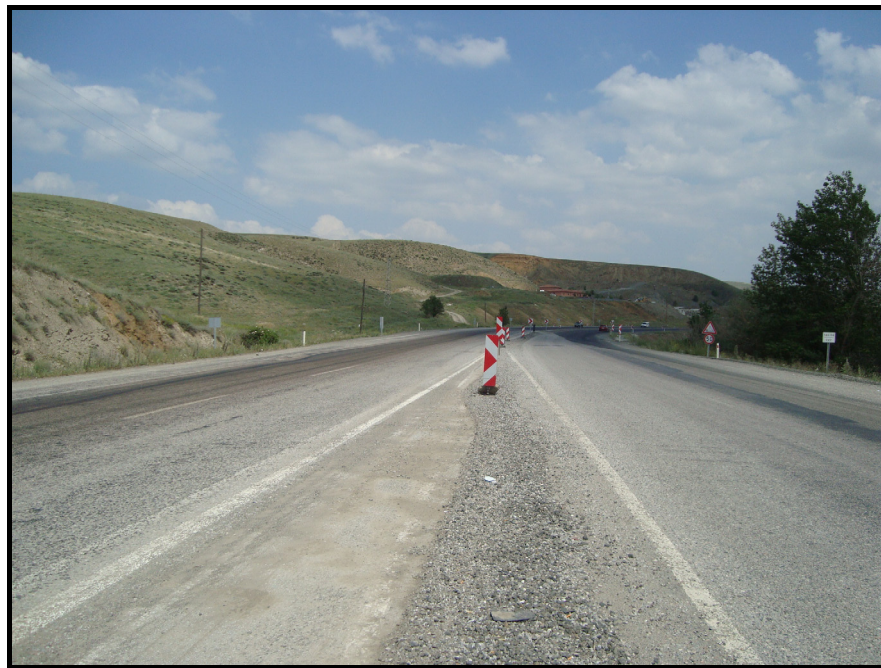
Figure 4.11 There is no ditch structure in the median zone

At the beginning section of the route the median width is 2 meters. There is no ditch structure in the median region. Because of unseen and worn horizontal sign the road is just divided with vertical warning signs. Because there is no ditch structure, it can become a potential contributing factor to crash severity (figure 4.11).

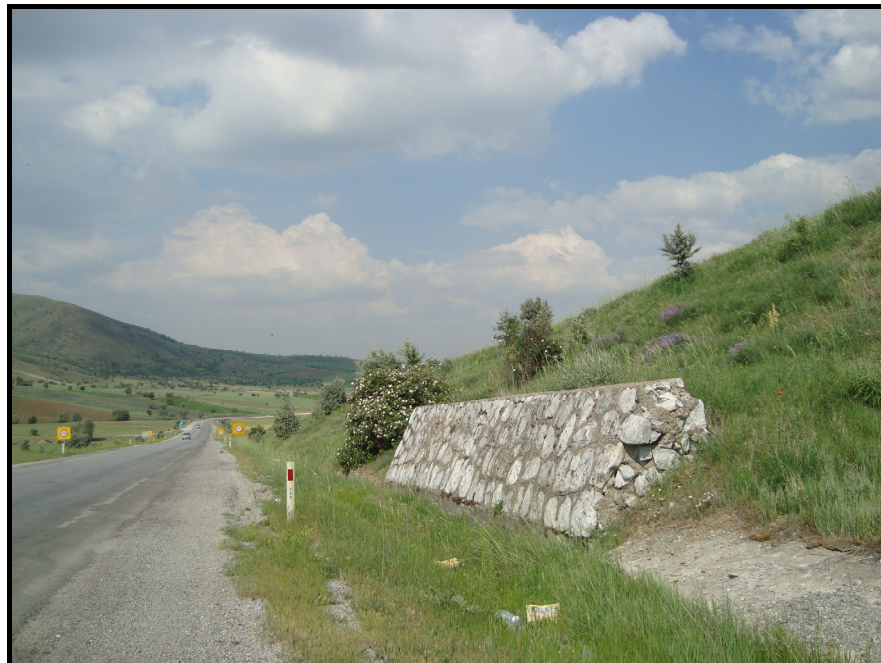
Figure 4.12 Shoulder missing

are not only too narrow but they are also unpaved. There is no exact width of the shoulders that are observed on undivided sections. It varies from 1.00 m to 2.00 m at undivided sections. Narrowing shoulder widths or loss of shoulder may cause serious safety problems (figure 4.12). This is particularly important since the lanes are 3- 3.5 meters in width and there is an extra width for other purposes.

Left side of the audit route shoulders is covered by some dangerous loose stone and rocks which are at station km 49+500. These stones or rocks can be thought as fixed objects that are almost on the shoulders. This area can be considered as potential accident location for road users.

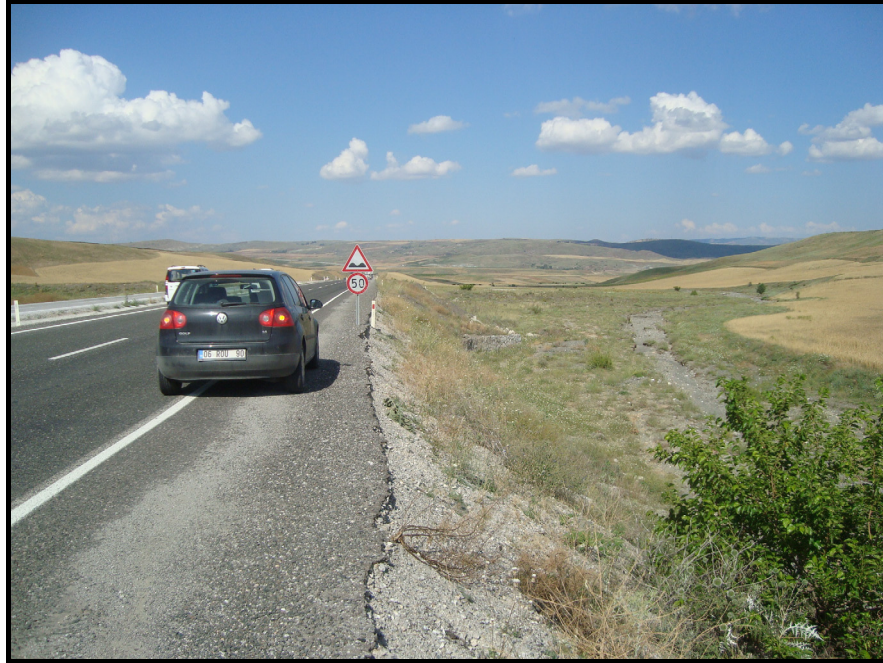
Figure 4.13 Improper sign usage in the shoulder zone

At divided sections speed limit is improper at some locations. The starting point of the audit route is a divided road. Because the section has good geometric standards;

the posted speed limit, which is 50 km/hr seems to be low (figure 4.13). Some section of the audit route is under construction so the speed limit selection is reasonable; it is 50 km/hr.

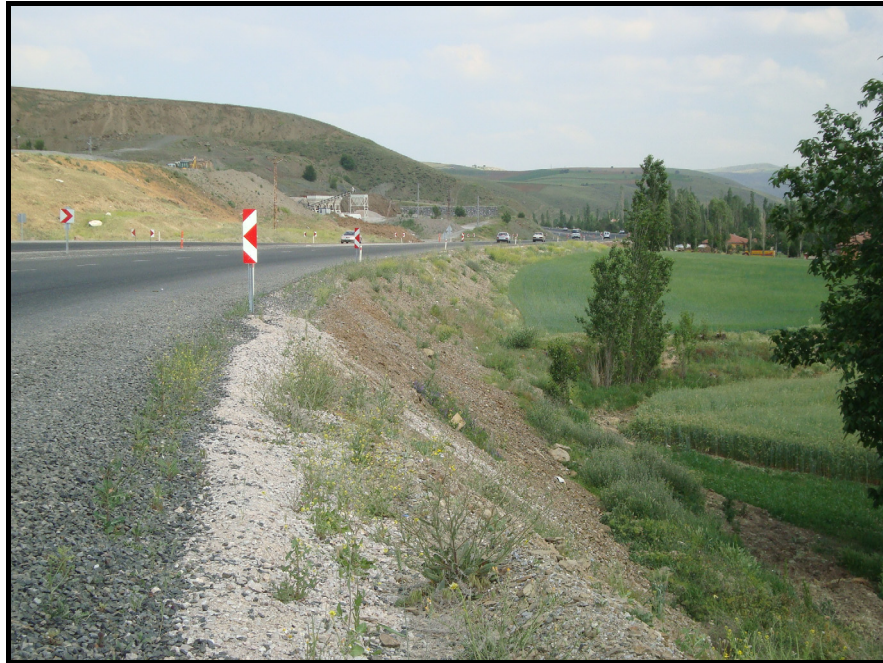
Figure 4.14 High steep sideslope zone

There are many road sections where the side slopes are less than desirable. “General Directorate of Turkish Highways” uses AASHTO standards. AASHTO considers side slopes of 4H:1V to be the steepest slopes for permitting safe vehicle controls. The first section of the audit route, the fill slopes are 1H:1V, 3H:2V, 2H:1V. High steep side slope at this area can cause a vehicle to overturn at run off roadway accidents. At station km 27+150, between km 27+500 and 27+700, and also between km 28+000 and 28+200; there are high steep side slopes (Figure 4.14). For slope stability and expropriation areas, there is a retaining wall structure. If an errant vehicle leaves the highway at these locations, the severity of the collision can be increased considerably. There are also many other steep side slope areas were recorded during the audit.

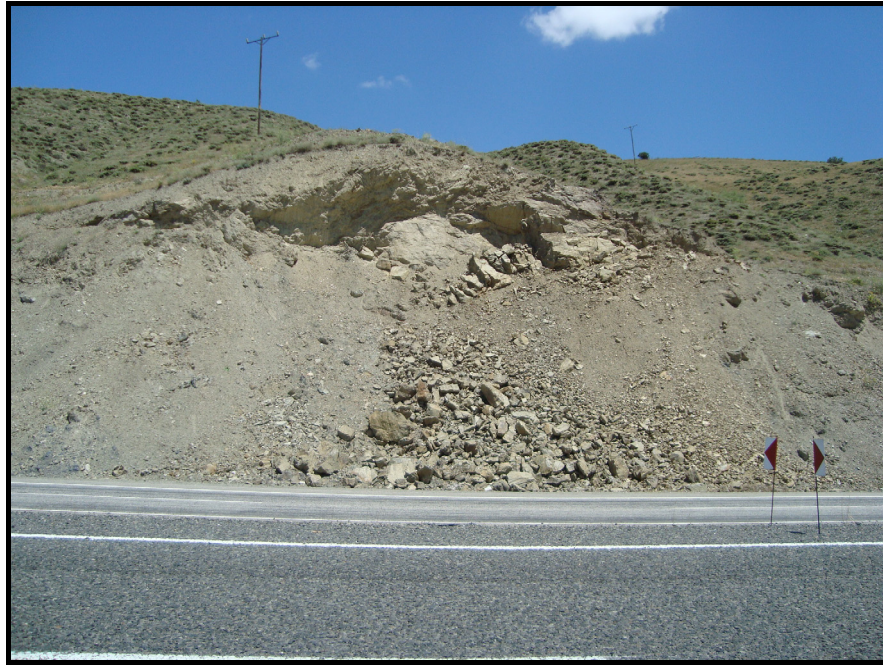
Figure 4.15 Dangerous cut slope area

Along the route, there are many cut slopes recorded and noted at the checklist. Most critical cut slope zone is just located at the beginning part of the route. Between the stations km 29+200 and 29+300 and between 31+600 and 32+200, claystone formation is dominate (Figure 4.15). Claystone can easily be dispersed and also it has a lamellar structure. Because of the claystone characteristics; the cut slopes can be considered as hazardous for road users.

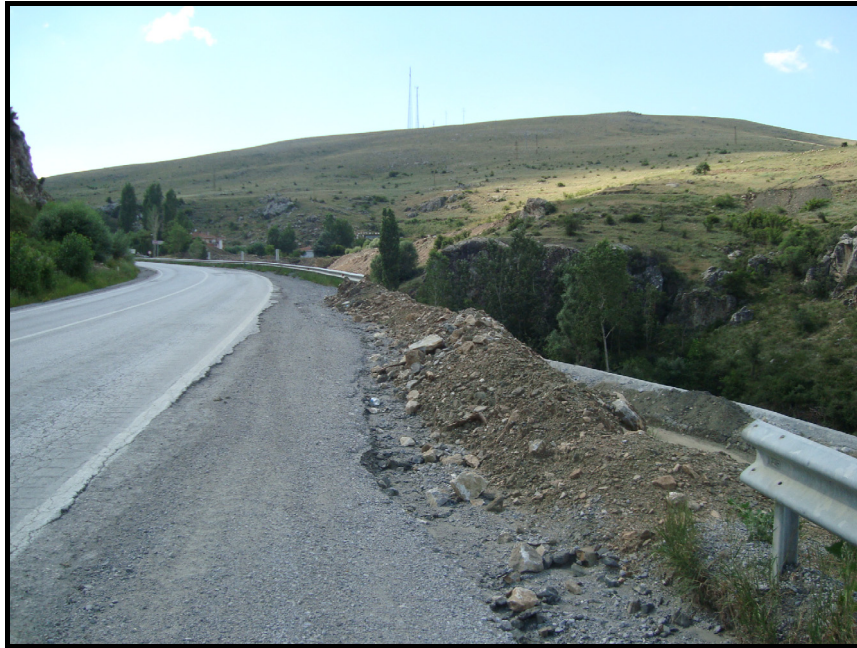
Figure 4.16 Dangerous guardrail section

Poorly designed or poorly positioned guardrails together with their improper terminations can become a roadside hazard. The guardrail was failed at station km 50+000. There is a dangerous gap at the middle section of the guardrail, because of this situation the guardrails end sections might increase the severity of accidents when hitting it.

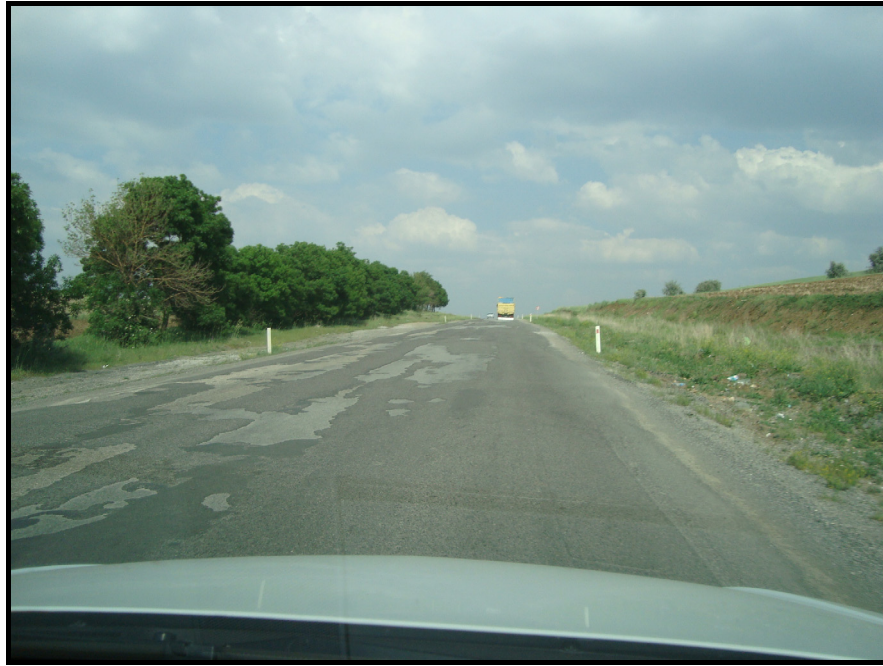
Figure 4.17 Improper pavement design

Within the study area, the condition of pavement varies according to the road classification. Generally, road surfaces appear to be roughest in fill cross sections with cracks, bumps and potholes on them. The pavement condition is particularly poor where the edge of the pavement meets the shoulders.

There is considerable rutting, resulting in ponding of water on roadway and there is also considerable raveling of pavement edges. There are many patches on the road surface. Because of this situation, at some sections road surface is rugged (Figure 4.17). At some sections, the road surface was collapsed because of the probable bad pavement design and construction. Generally the condition of the road surface is poor throughout the section.

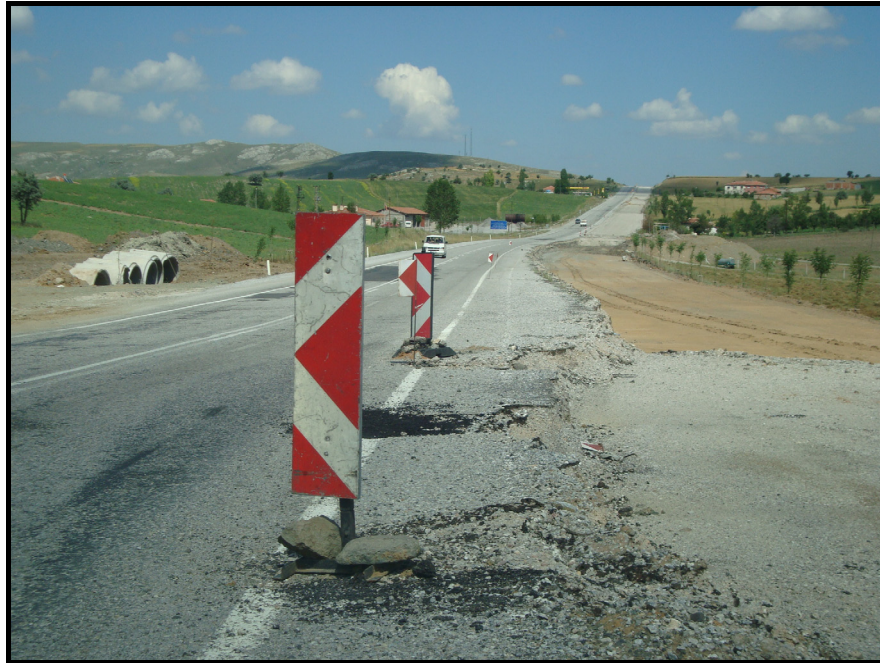
Figure 4.18 Improper location of warning sign

Road construction has been conducted at some sections through the audit route. At station km 42+400 the warning sign is under another warning sign. These signs can create confusion for road users. At station km 45+600 another warning sign is just inside the lane of the road and it is temporarily fixed with stones (Figure 4.18). Because the sign limits the existing lane, it can create danger especially for heavy vehicles. At another construction site; on the route between km 50+400 and 50+900, there are flagpersons for directing the traffic movement. On the other hand, the location of the flagpersons can also cause accidents.
