**IN-DEPTH ACCIDENT ANALYSIS AND CASE STUDY IN
NIGERIAN ROAD AND TRAFFIC CONDITION**

**A THESIS SUBMITTED TO
THE GRADUATE SCHOOL OF NATURAL AND APPLIED
SCIENCE
OF
ATILIM UNIVERSITY**

IN THE DEPARTMENT CIVIL ENGINEERING

MARCH 2014

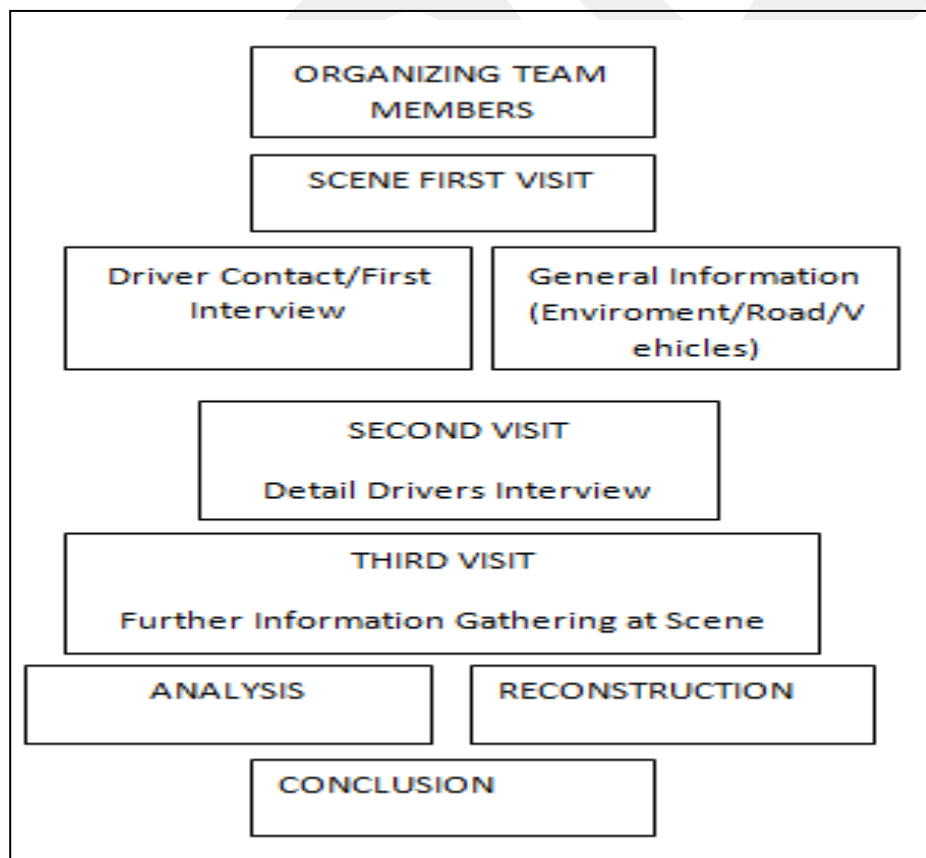
Figure 8 Applied Investigation Procedures

d) Third Visit; the team re-visited the accident scene for the second time to obtain all other information which was not filled during the first visit.

e) Analysis; the team members study the filled questionnaire for the presence of mistakes and omissions, analyzed the accident based on accident mechanism, the sequence of events, and system analysis to understand the causes of the accident.

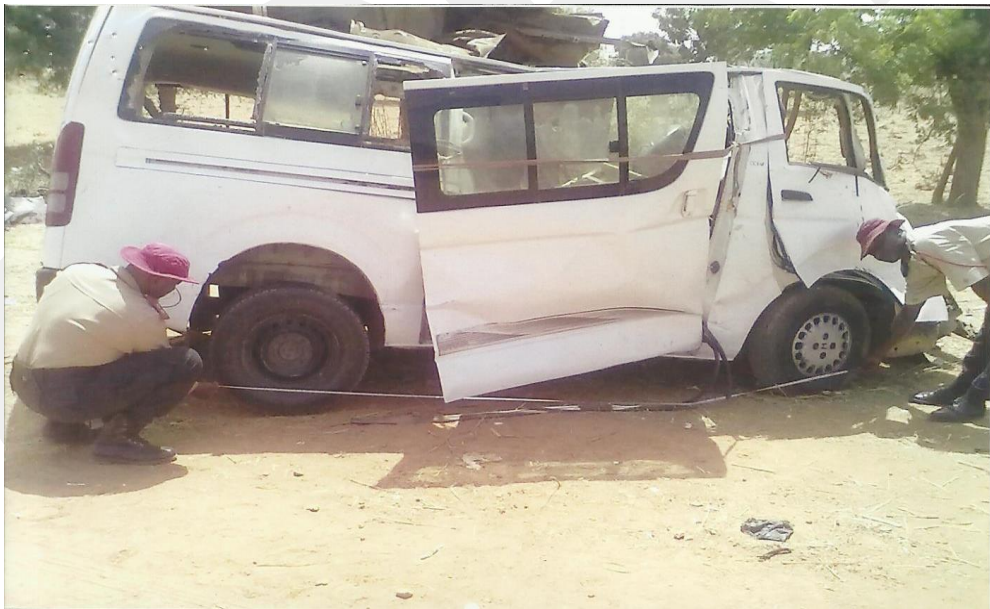
Side View of the Involved Bus

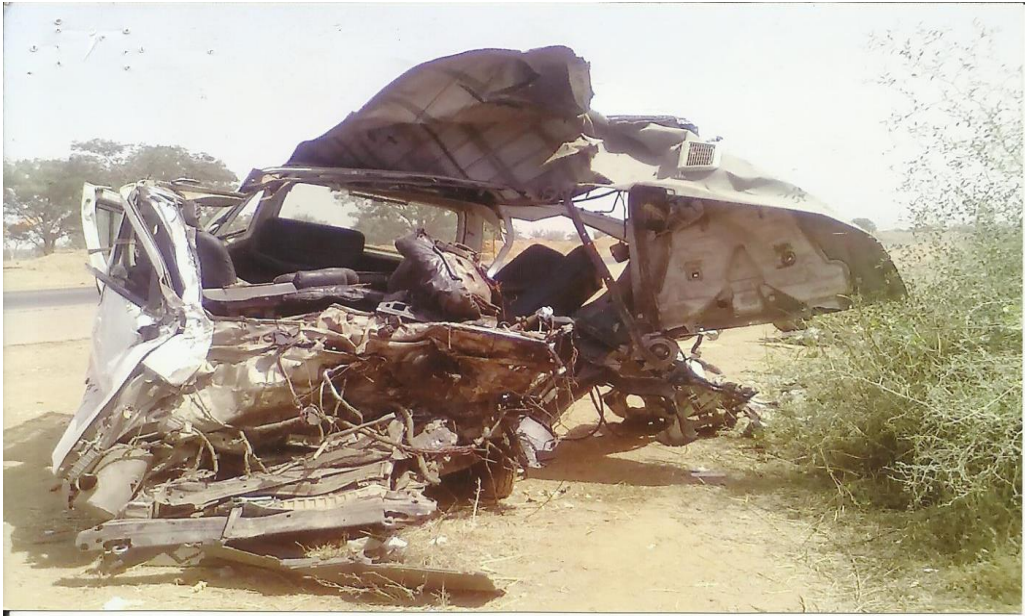
Front View of the Involved Bus

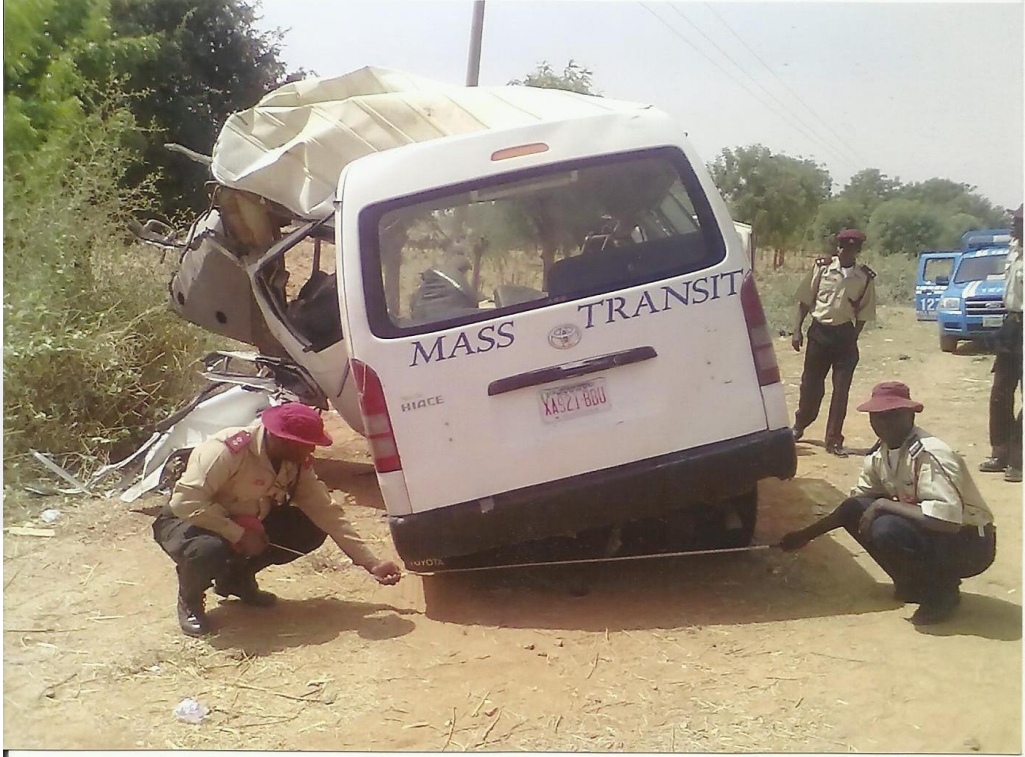
Rear View of the Involved Bus

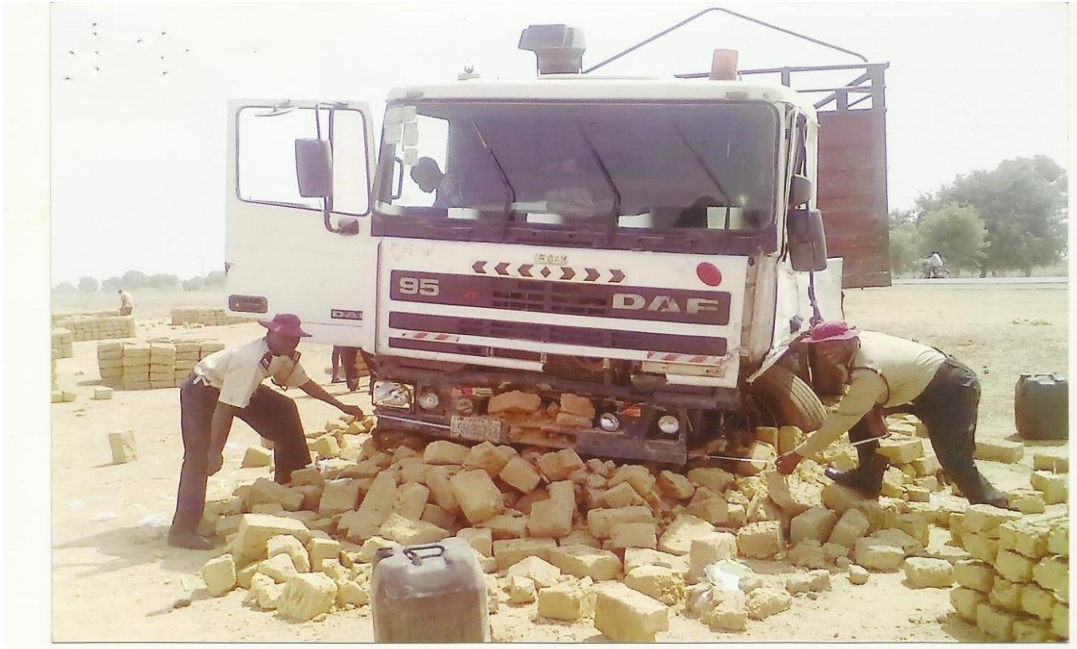
Front View of the Involved Truck in the Rest Position

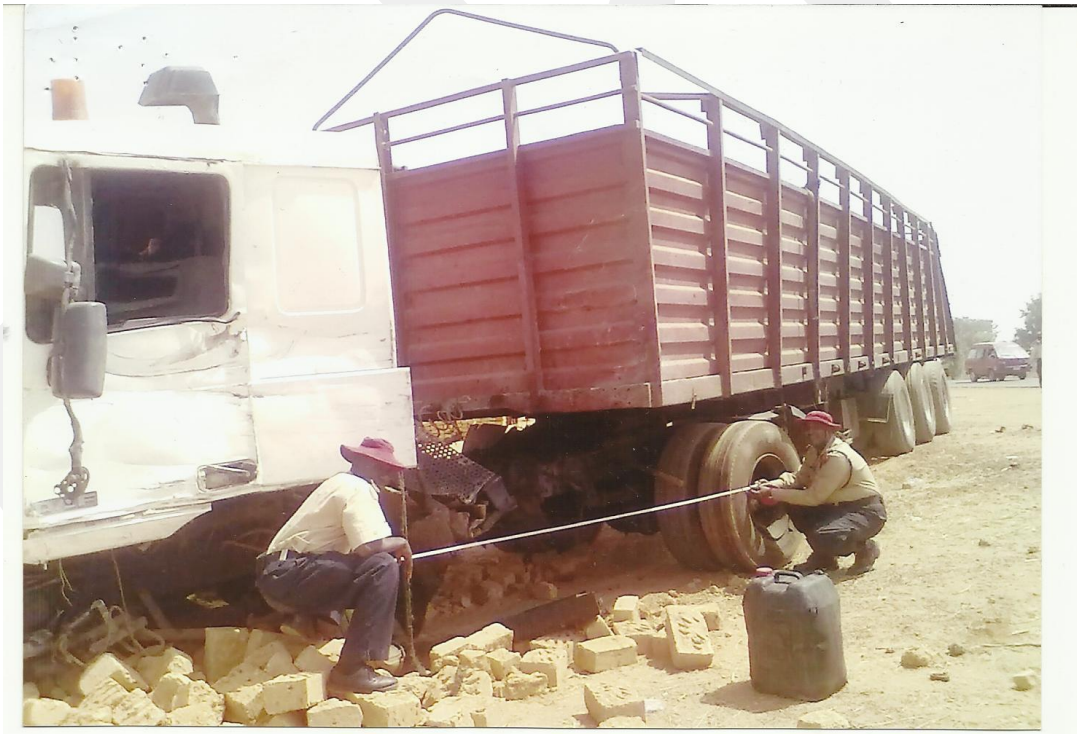
Side View of the Involved Truck in Its Rest Position

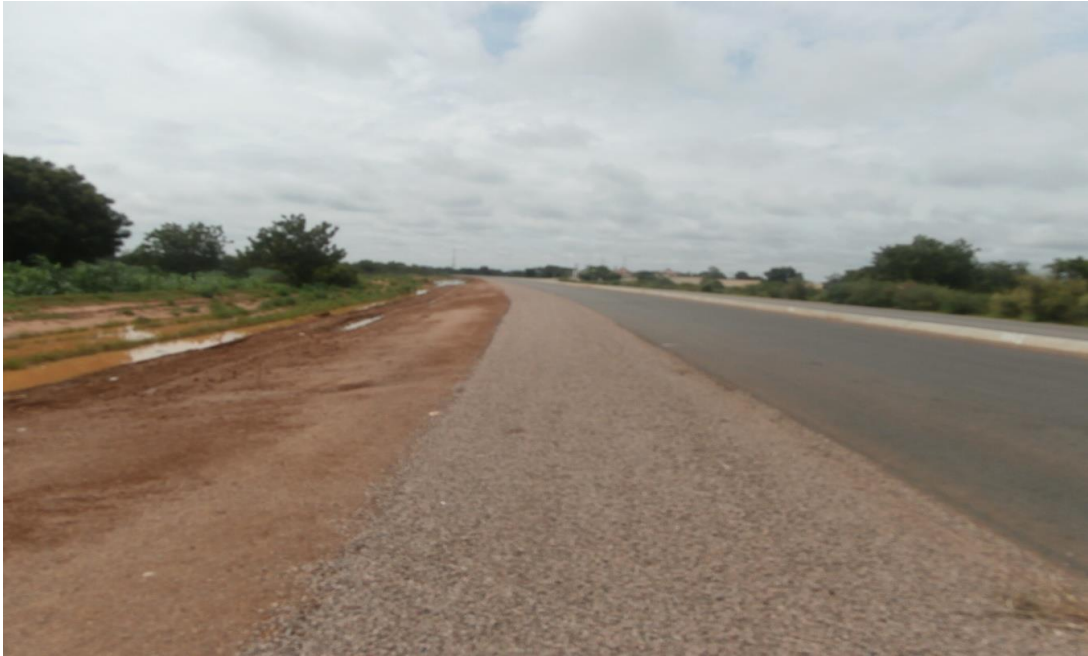
Road Cross-Section Showing Various Road Elements

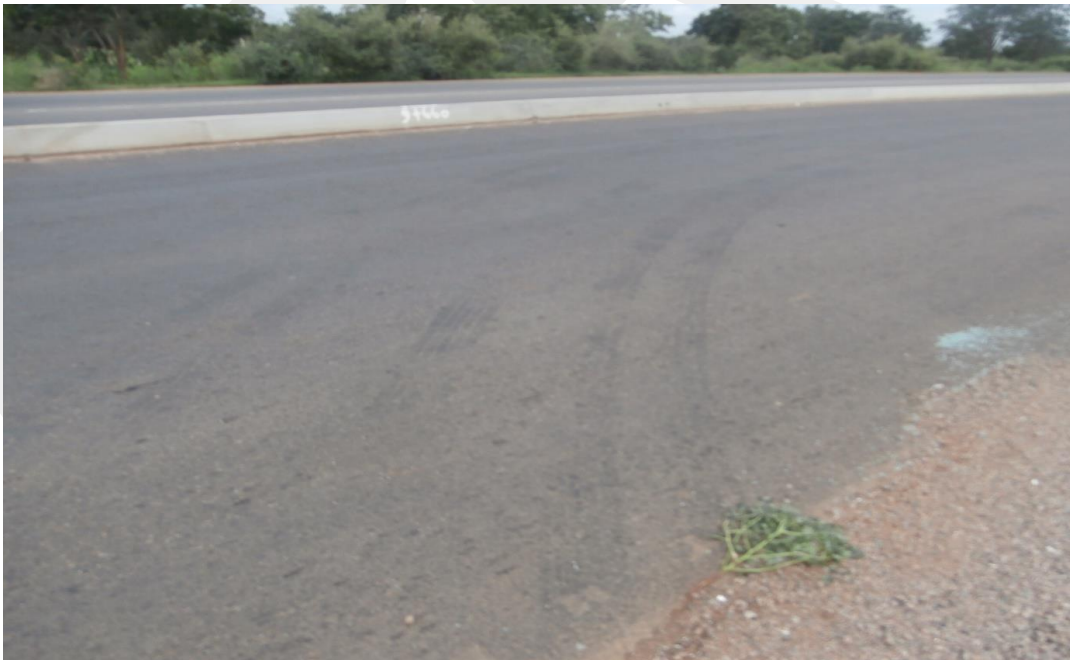
PICTURE SHOWING SKID MARKING PRODUCE BY THE INVOLVED BUS

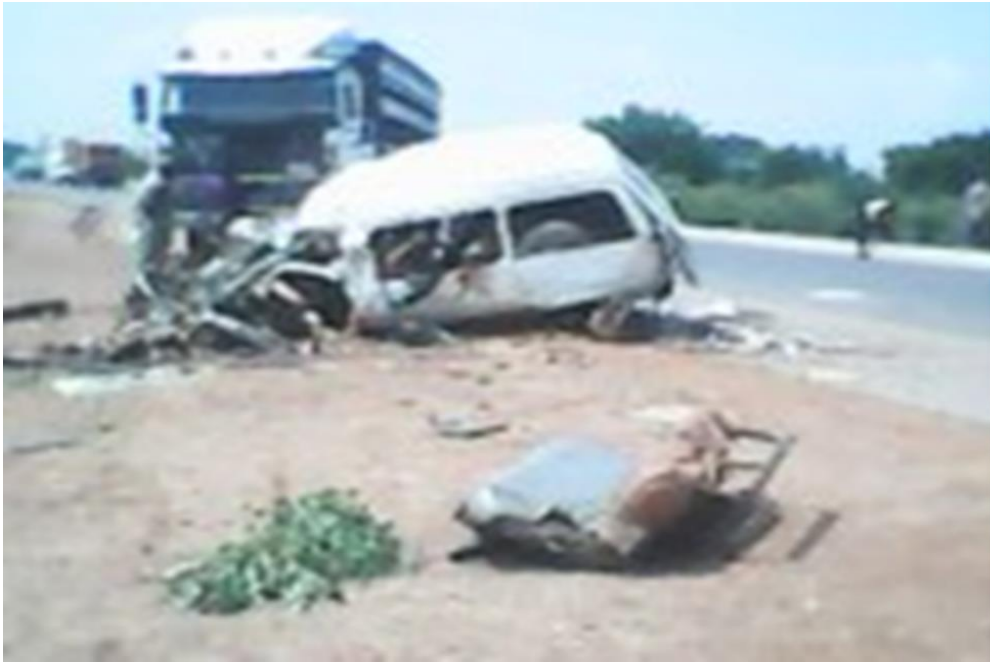
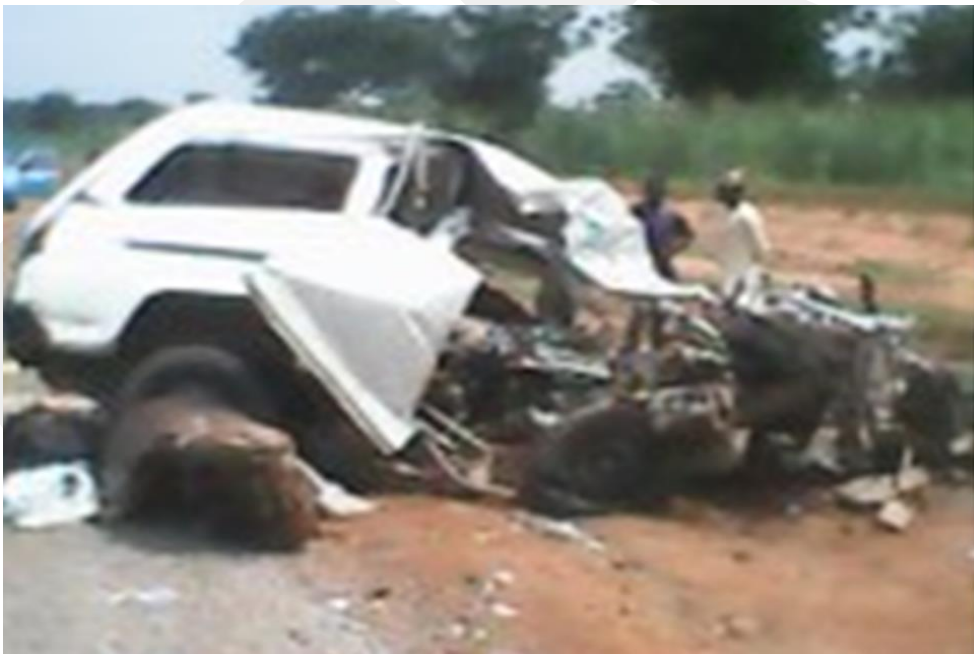
Front View of the Involved Bus

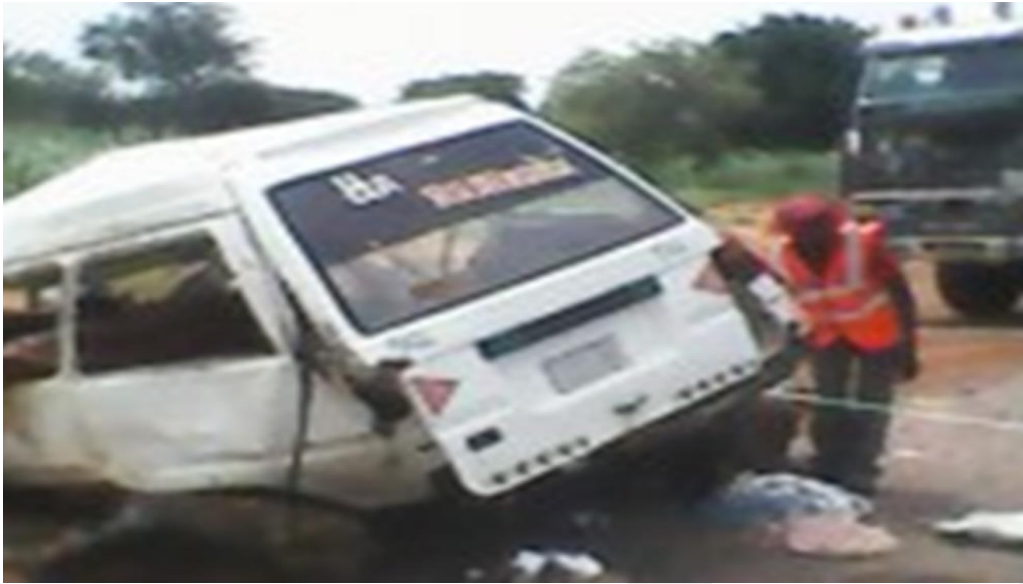
Rear View of the Involved Bus

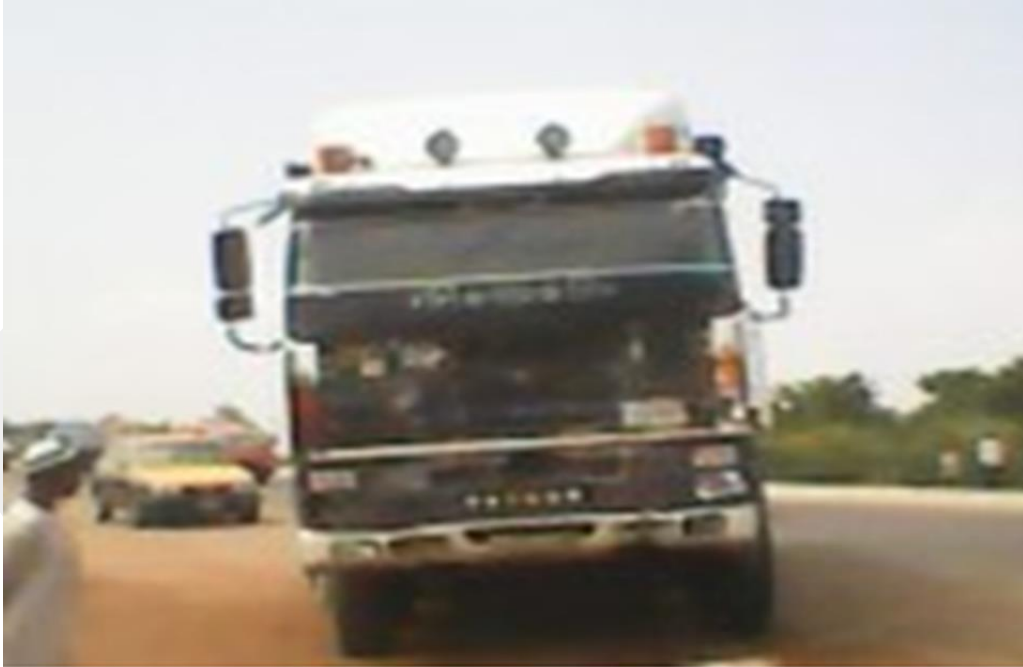
FRONT VIEW OF THE INVOLVED TRUCK

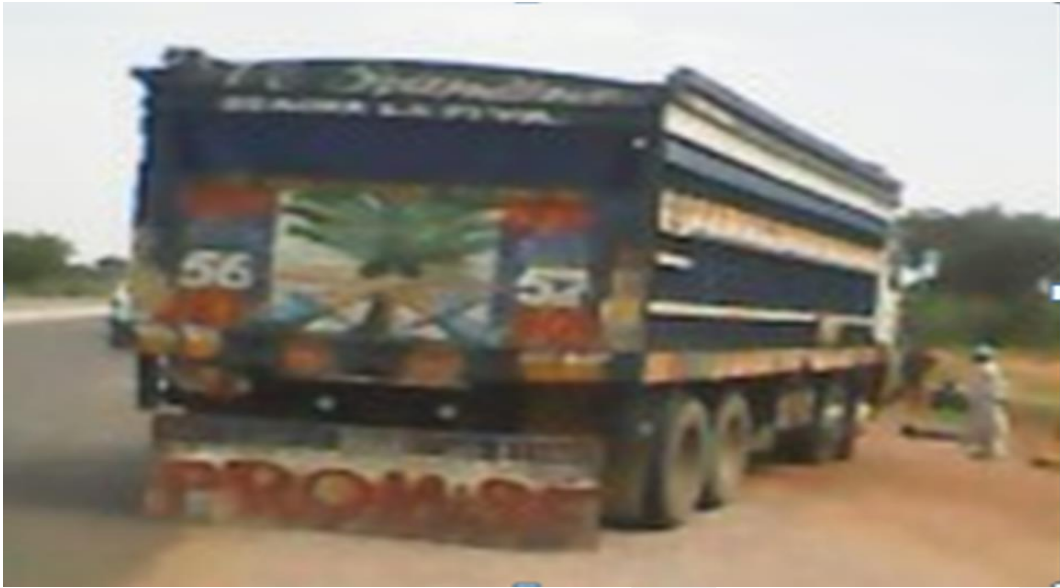
REAR VIEW OF THE INVOLVED TRUCK

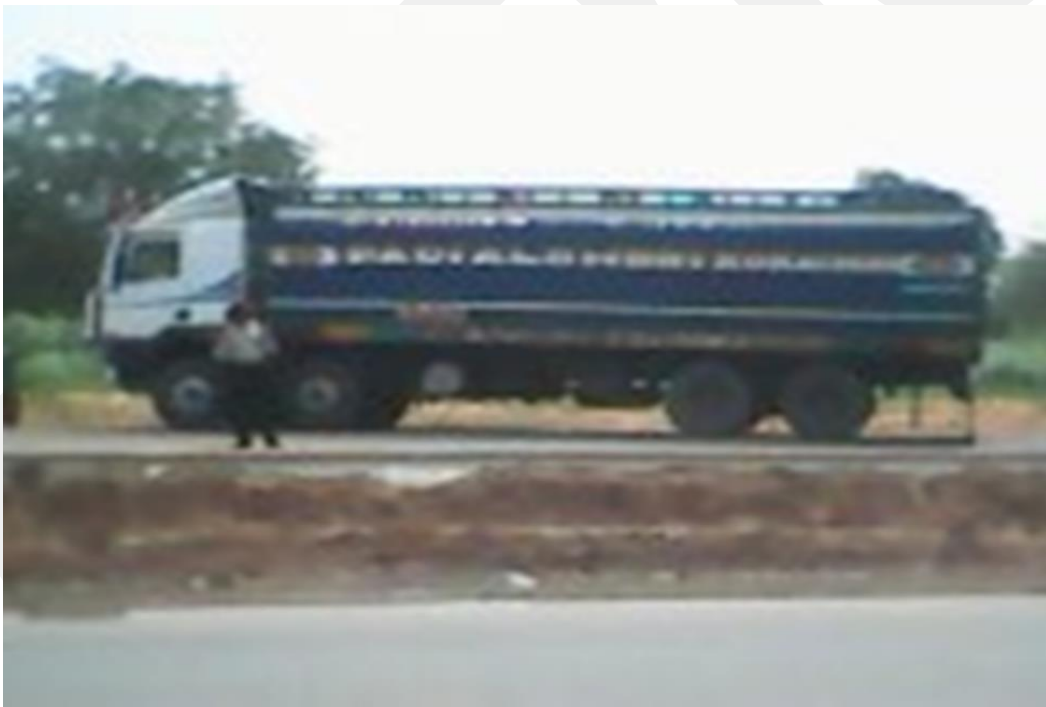
SIDE VIEW OF THE INVOLVED TRUCK

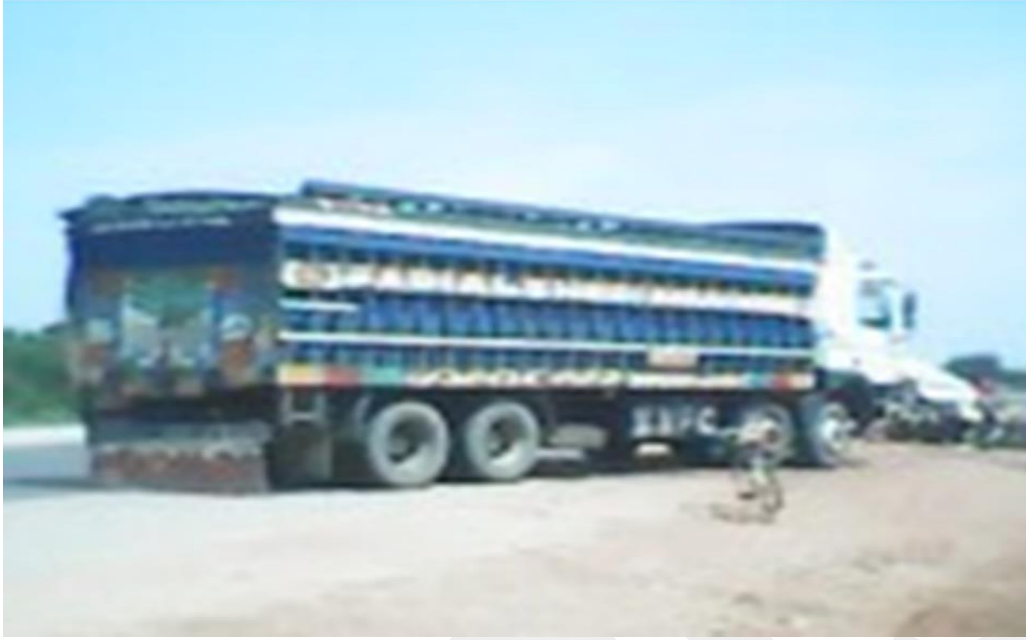
SIDE VIEW OF THE INVOLVED TRUCK
