# Seismic Hazard Evaluation of RC Buildings in İzmir after The Aegean Sea Earthquake on October 30, 2020

**Halit Cenan Mertol<sup>1</sup>, Gokhan Tunc<sup>1</sup> & Tolga Akis<sup>1</sup>**

*<sup>1</sup>Civil Engineering Department, Atilim University, Ankara, Turkey*

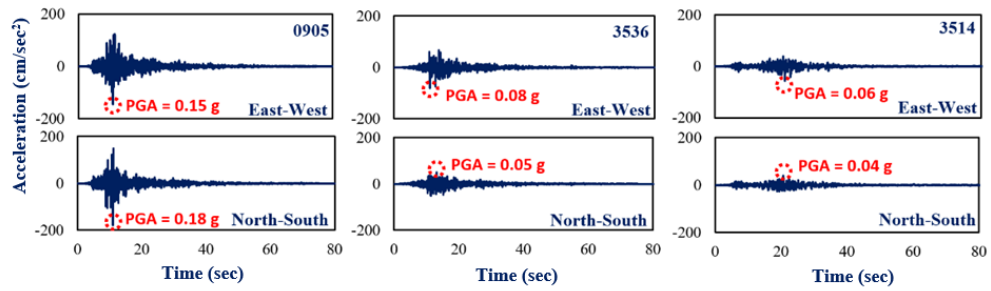
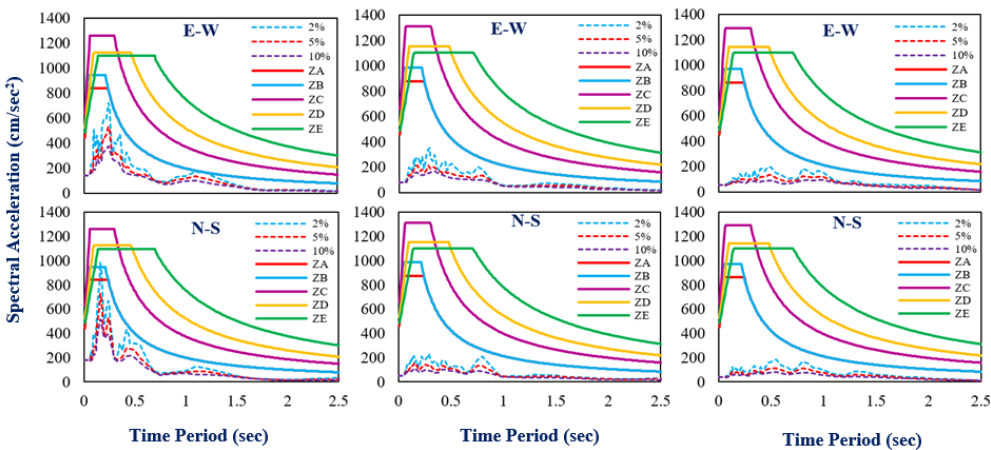
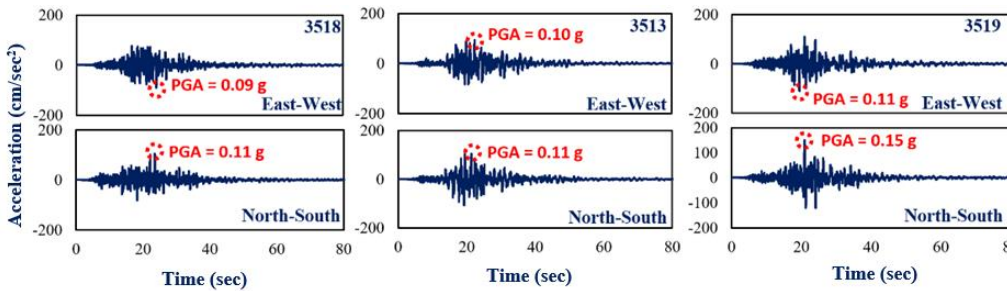
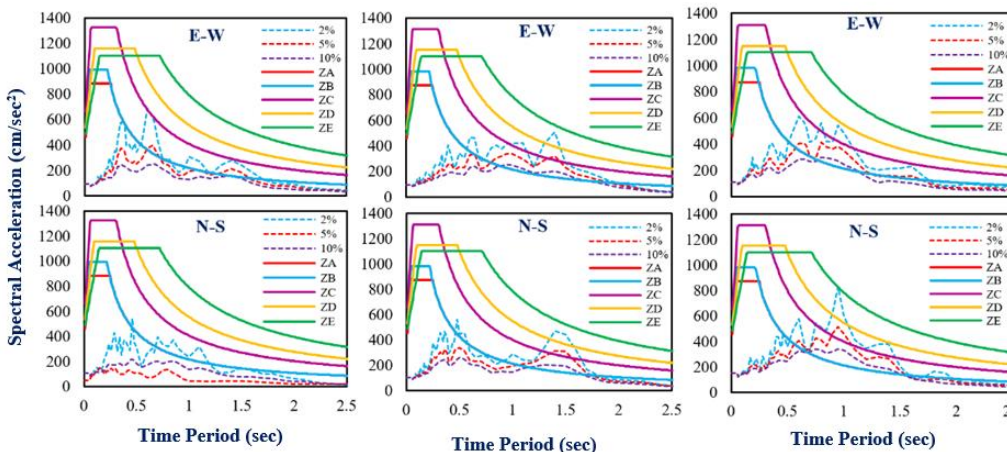
**Figure 16.** Peak ground and spectral acceleration values and design spectrum values for the Aegean Sea Earthquake, October 30, 2020

1 The design spectrum curves of the current Turkish Building Earthquake Code (TBEC, 2018) [41] were  
 2 compared to the measured spectral acceleration data, which were extracted from the six stations in  
 3 the North-South and East-West directions as a function of varying damping ratios (see Figure 16).  
 4 TBEC (2018) [41] defines a total of 6 local soil classes, identified by letters ZA through ZF, where ZA  
 5 defines a soil type of hard rock, and ZF defines a soil type of extremely loose soil, which needs further  
 6 soil testing and site evaluation. In this study, the design spectrum curves of the first 5 soil classes  
 7 (excluding soil type ZF) were used to evaluate the North-South and East-West peak ground  
 8 acceleration components of the Aegean Sea earthquake. Based on the spectrum values, the peak  
 9 ground acceleration values at station numbers 3536 and 3514 were much less than the demands

10 associated with the 5 soil classes. Therefore, the structural damage at these locations were moderate  
 11 to minor. However, as the seismic waves travelled along station numbers 0905, 3518, 3513 and 3519,  
 12 their corresponding periods for the peak ground accelerations shifted from 0.2 to 1.5 seconds. This  
 13 shift exceeded the code generated design response spectrum values, specifically at station numbers  
 14 3513 and 3519, for all four soil types, except type ZE. As a result of this exceedance, the degree of  
 15 structural damage varied from moderate to intense in RC buildings with 8 to 15 floors.

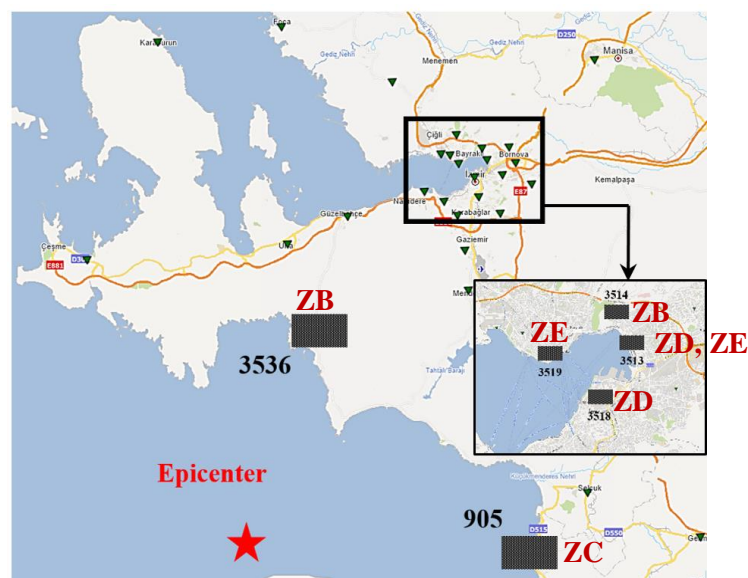
31 **Figure 17.** Local soil classes for the selected six stations

16  
 17 In order to further evaluate the impact of the Aegean Sea earthquake, the local soil classes of the  
 18 selected stations were taken into account. Figure 17 shows the soil classes at these stations [42].  
 19 Based on this data, the soil properties of the İzmir Bay area are found to be the weakest since almost  
 20 all the stations are located in soil classes ZD or ZE, which confirms the soil properties explained in  
 21 Section 2.3. As expected, the weak soil amplified the peak ground acceleration and extended the  
 22 effective time duration by causing building collapses and severe structural damage. Although station  
 23 numbers 3518 and 3519 both displayed a very similar acceleration pattern to station number 3513, the  
 24 building damage near these two stations were not as severe as those at 3513. The severe building  
 25 damage near station number 3513 are largely attributed to the regions' local soil type (alluvial plain

26 and delta deposits) (see Figure 8-b). The other reason for this problem is the lack of geotechnical  
 27 studies, which were not mandated at the time of construction (for further information see Section  
 28 4.5.5).

- 12 • The local soil class (site effect) is an important parameter to be incorporated into the earthquake  
13 analysis and design of a building. The buildings in Bayraklı suffered mostly from this phenomenon.  
14 Therefore, it is recommended that thorough earthquake analyses shall be performed for all  
15 existing buildings in the area.

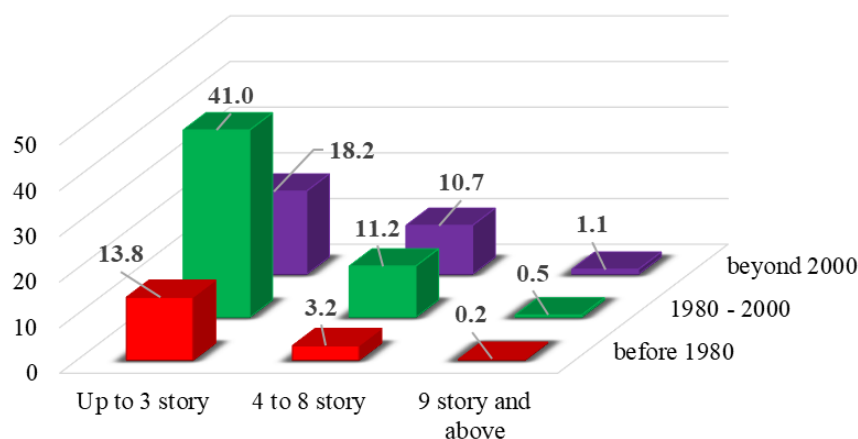
Figure 18. Distribution of RC buildings in Izmir by percent (adapted from [14])

As illustrated in Figure 18, 73% of the RC buildings have up to 3 floors, 25% of them have 4 to 8 floors, and the remaining (almost 2%) have 9 floors and above. As a group, 70% of these RC buildings were built before 2000. There were mainly two earthquake codes in effect at the time, the 1975 and 1998 earthquake codes. Based on the number of years and buildings constructed, it is accurate to state that out of 70% of the buildings, almost 60% of them were built according to the rules and regulations of the 1975 Turkish earthquake code.

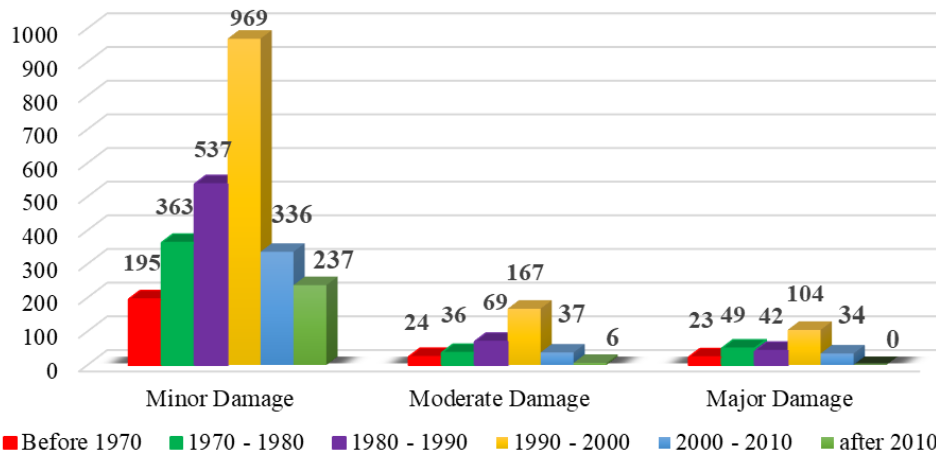
14  
 15 **Figure 19.** Distribution of damage in İzmir's RC buildings by numbers (adapted from [14])

8  
 9 The distribution of the damage levels of the RC buildings in İzmir is also plotted in Figure 19, as a  
 10 function of their construction years. As the data indicates, most of the moderate to major size damage  
 11 was observed in buildings constructed between 1990 and 2000. Beyond 2010, it was observed that  
 12 the damage level shifted towards minor level damage.

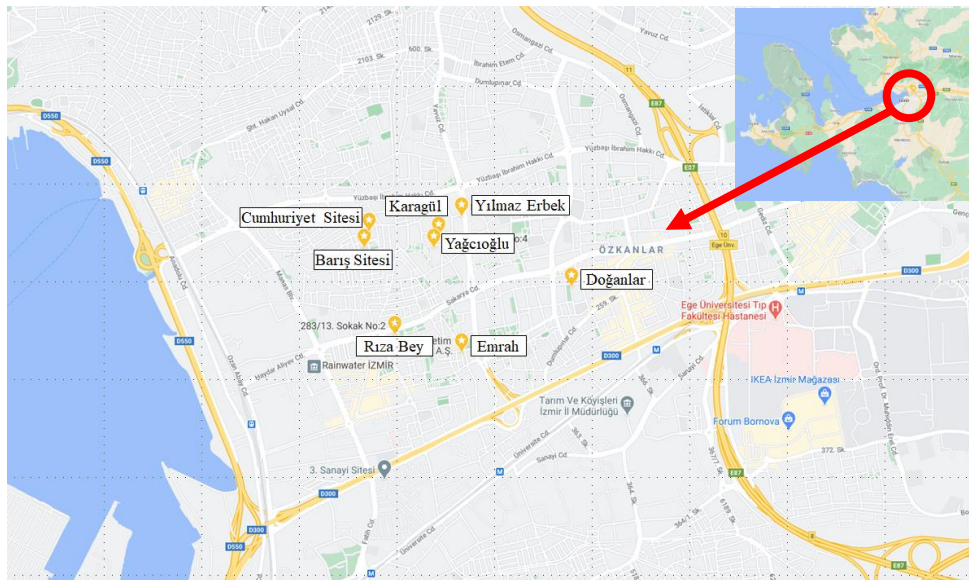
**Figure 20.** Locations of collapsed buildings in the Bayraklı District

18 As stated in Section 1, the earthquake caused the sudden collapse of 11 RC buildings. Out of these  
 19 11 RC buildings, 4 of them (Rıza Bey, Doğanlar, Emrah, and Block B of Yağcıoğlu Apartment  
 20 Complex) completely collapsed and 7 of them (Yılmaz Erbek and Karagül Apartments, three blocks in  
 21 the Barış Apartment Complex and two blocks in the Cumhuriyet Apartment Complex) partially  
 22 collapsed in the Bayraklı District during the earthquake. All the collapsed buildings had structural  
 23 framing systems consisted of reinforced concrete columns and beams. These frames were infilled  
 24 using brick masonry at all the story levels except the ground story. Most of them had shops at the  
 25 ground story which may have produced weak story at the ground floor levels. General information  
 26 related to the collapsed buildings is shown in Table 5. The locations of these buildings are shown in

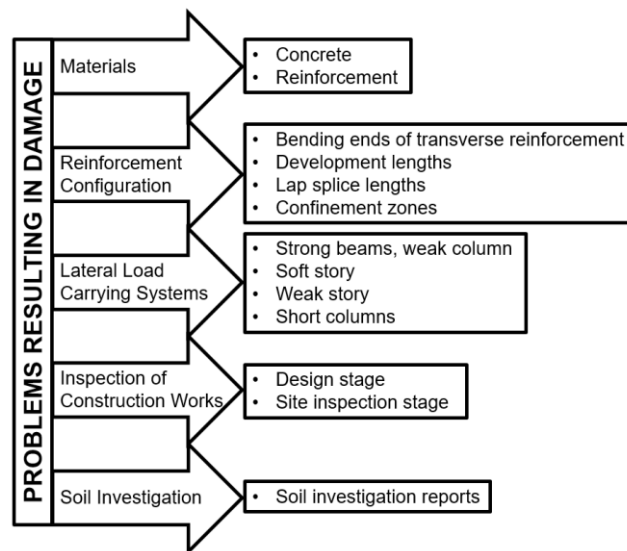
**Figure 32.** Summary of the problems resulting in damage

Summary of the problems resulting in damage and collapses is shown in Figure 32. It is important to note that these problems are not just common to RC buildings in Turkey but are also common to other types of buildings, such as masonry and timber ones, resulting from the past earthquakes that occurred in the region and around the world [55, 56 and 57]. Details of these problems are explained in the following sub-sections.
